Final Report:
1999 South Fork Garcia River
Watershed Erosion Control and Prevention Project,
SB271 Road Upgrading and Decommissioning Project

California Department of Fish and Game,
Mendocino Redwood Company,
&
Mendocino County Resource Conservation District

by
Trout Unlimited,
Albany, California,
(510) 528-4772,
&
Pacific Watershed Associates,
Arcata, California,
(707) 839-5130

April 2002

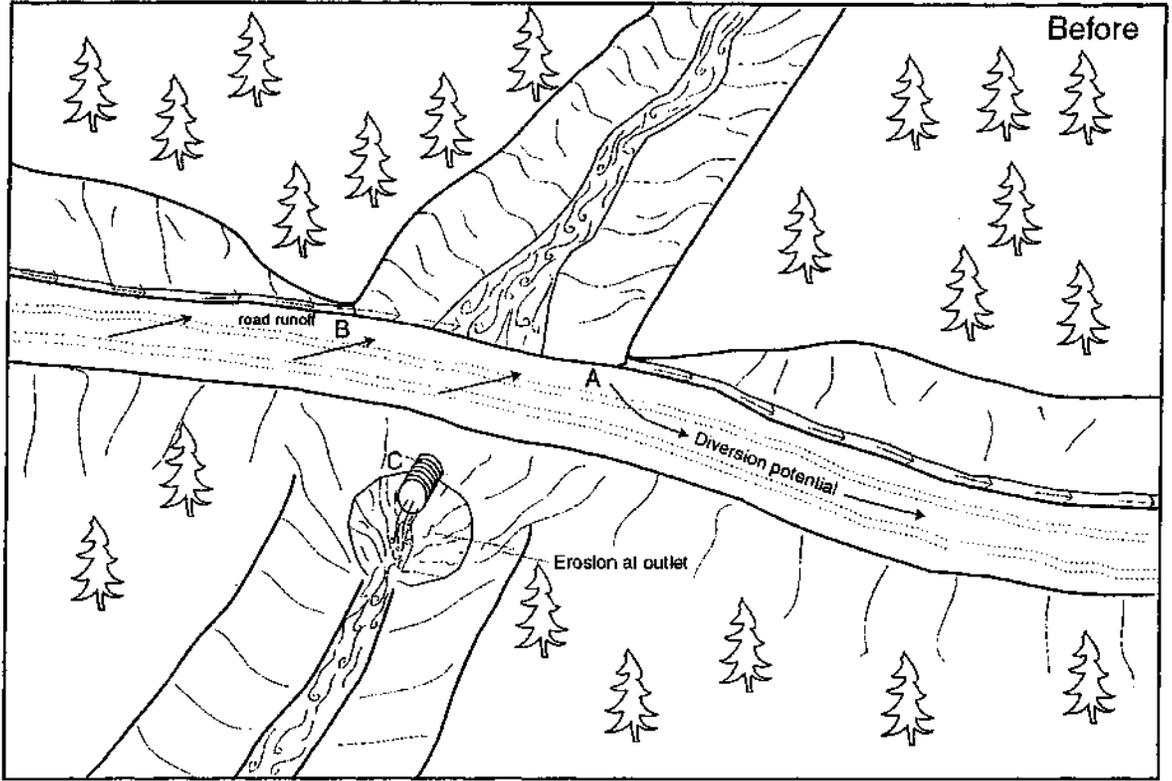
Common problems

- A - Diversion potential
- B - Road surface and ditch flows drain to stream
- C - Undersized culvert high in fill with outlet erosion

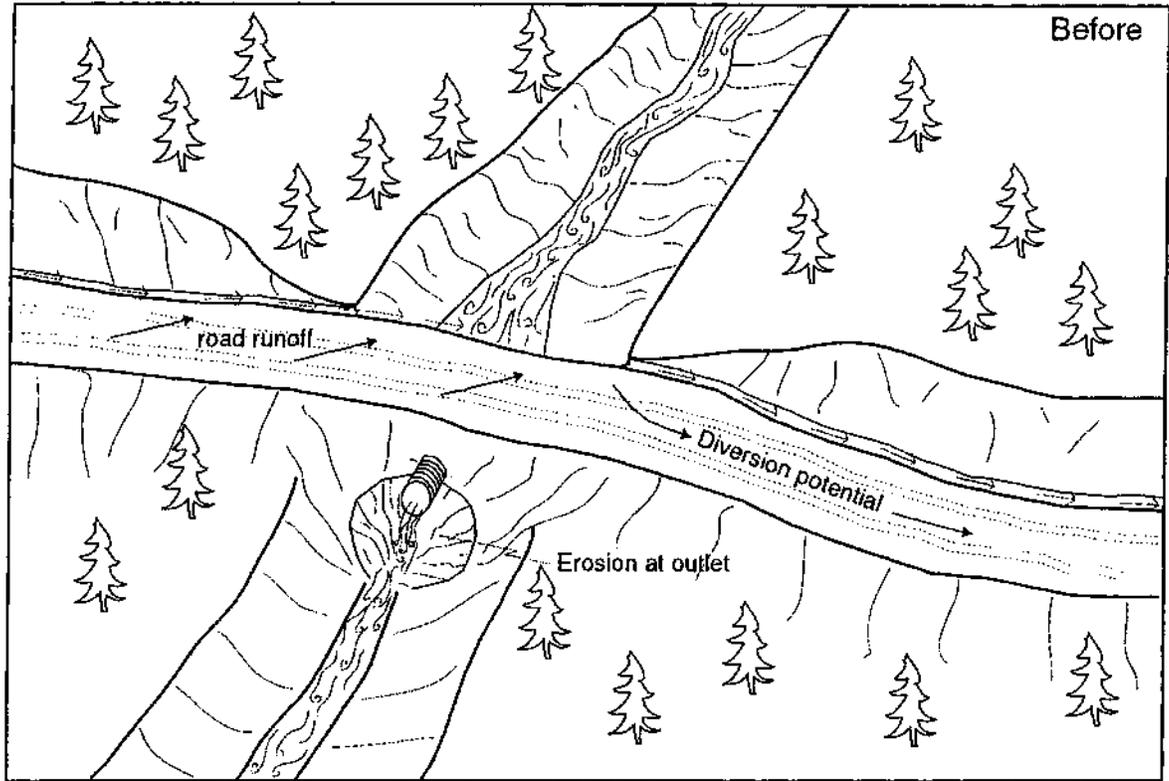
Condition

- Diversion potential
- Road surface and ditch flows drain to stream
- Undersized culvert high in fill with outlet erosion and elevated plugging potential

- Road surface decompacted
- Cross road drains on old road
- Stream crossing fill completely excavated
- Excavated spoil used to outslope adjacent road

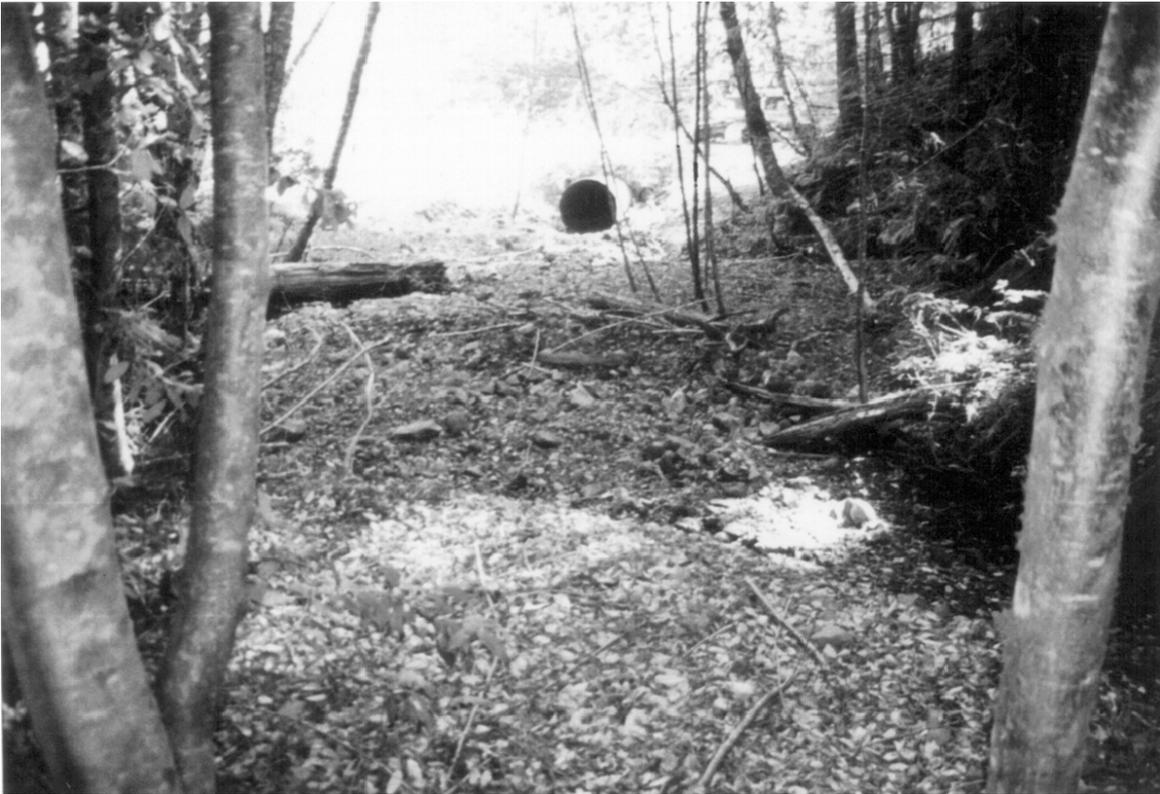
Figure 1. Site 50, G-006 Road. Before photo of site conditions looking downstream across large plain of channel stored sediment, with undersized 6 foot diameter culvert under the roadway.

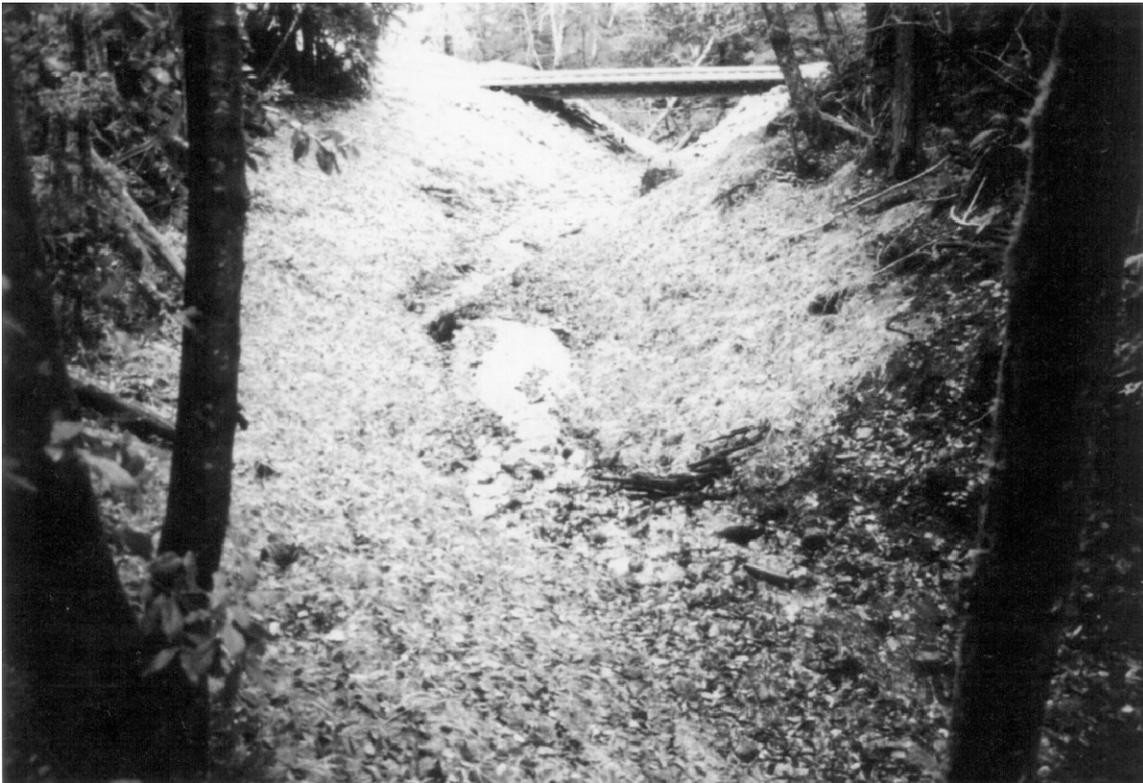
Figure 2. Site 50, G-006 Road. After photo looking downstream from the same location. All channel stored sediment and the culvert crossing have been excavated, and a flatcar bridge has been installed. The bridge was purchased with contributions from the MCRCD.

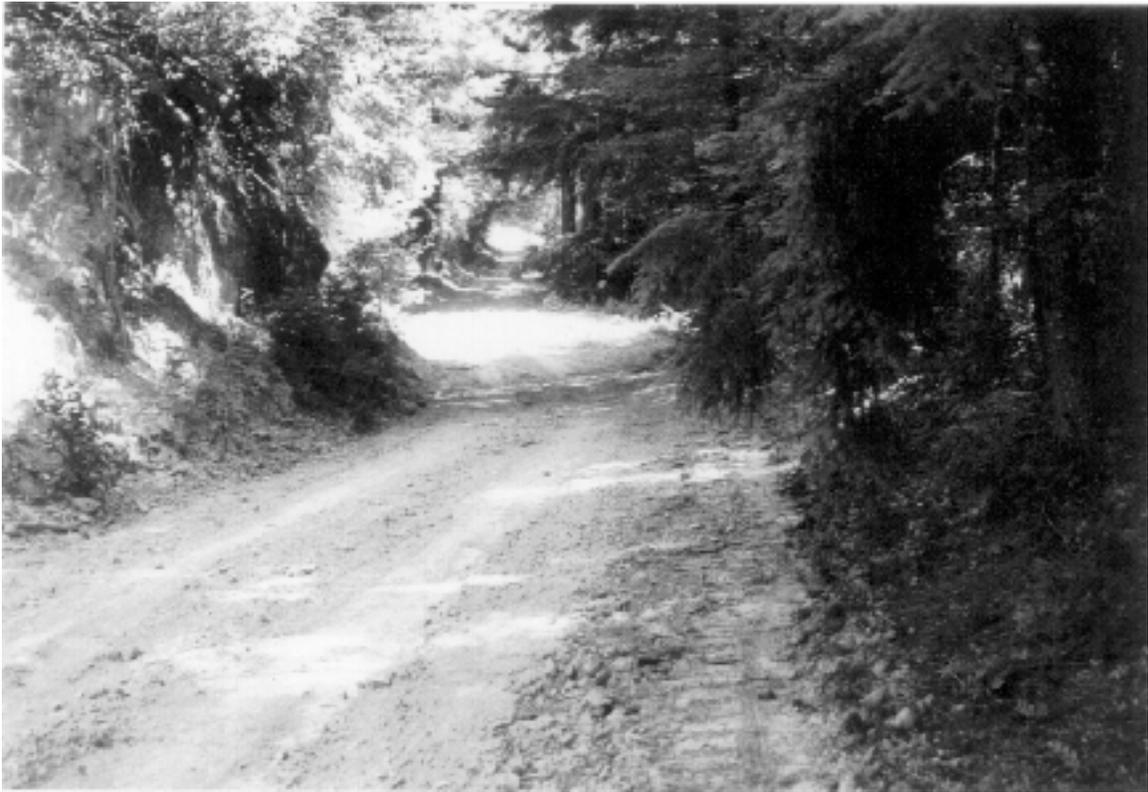
Figure 3. Site 13, B-Line. View looking down the road before erosion control efforts. The road bed in the middle portion of the photo between the cutbank and the twin redwoods in the distance has been constructed in a class 2 stream bed.

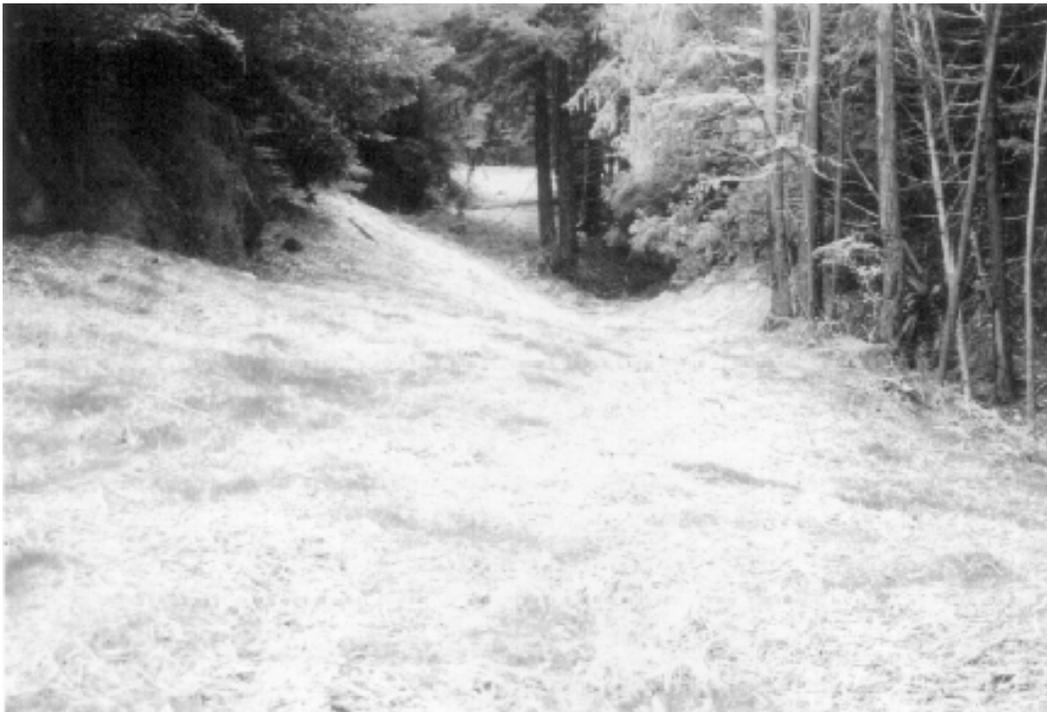
Figure 4. Site 13, B-Line. After treatment photo taken from the same location. The road bed has been decommissioned through this reach and a new 1000 foot section of no impact road has been constructed (not shown in the photo) to bypass this reach of road. The road was "put-to-bed" by excavating sidecast fill and outsloping the road. In the middle portion of the photo natural stream channel capacity has been re-established.

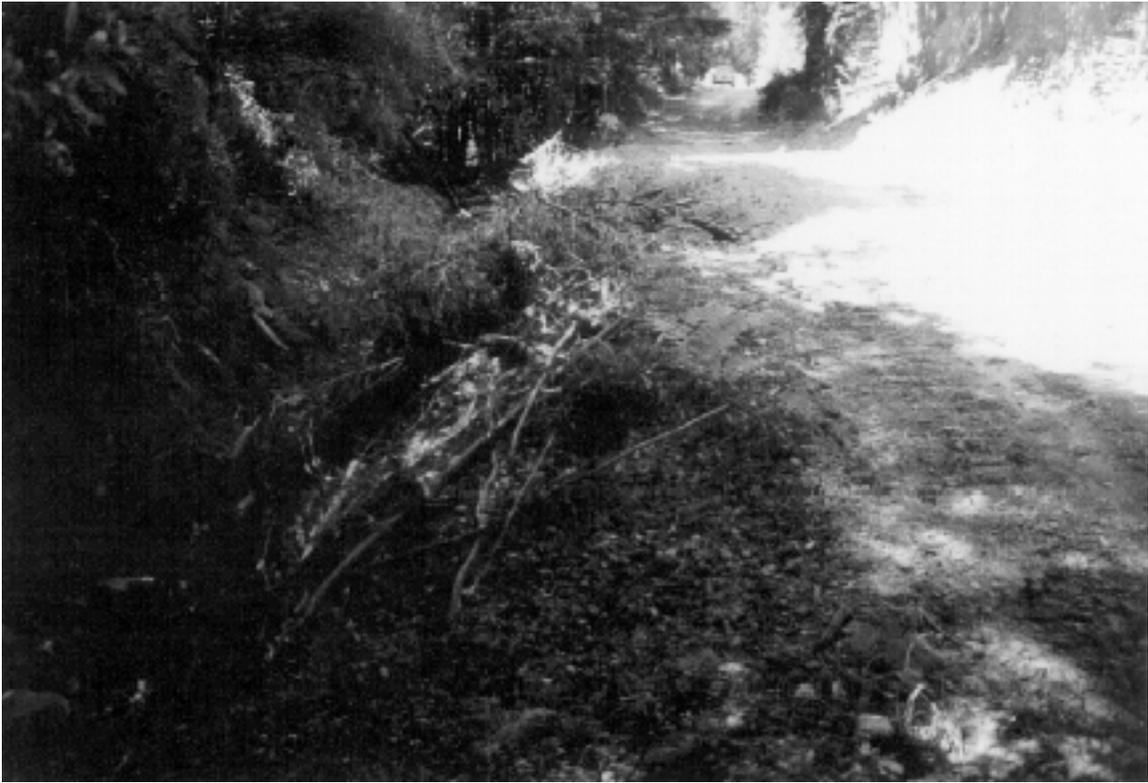
Figure 5. Site 13, B-Line. View upstream at the same reach of road seen in Figures 3 and 4. The truck in the distance is at the photo point where Figures 3 and 4 were taken. The natural stream channel flows toward the camera and is significantly constricted by introduced road fill and slash.

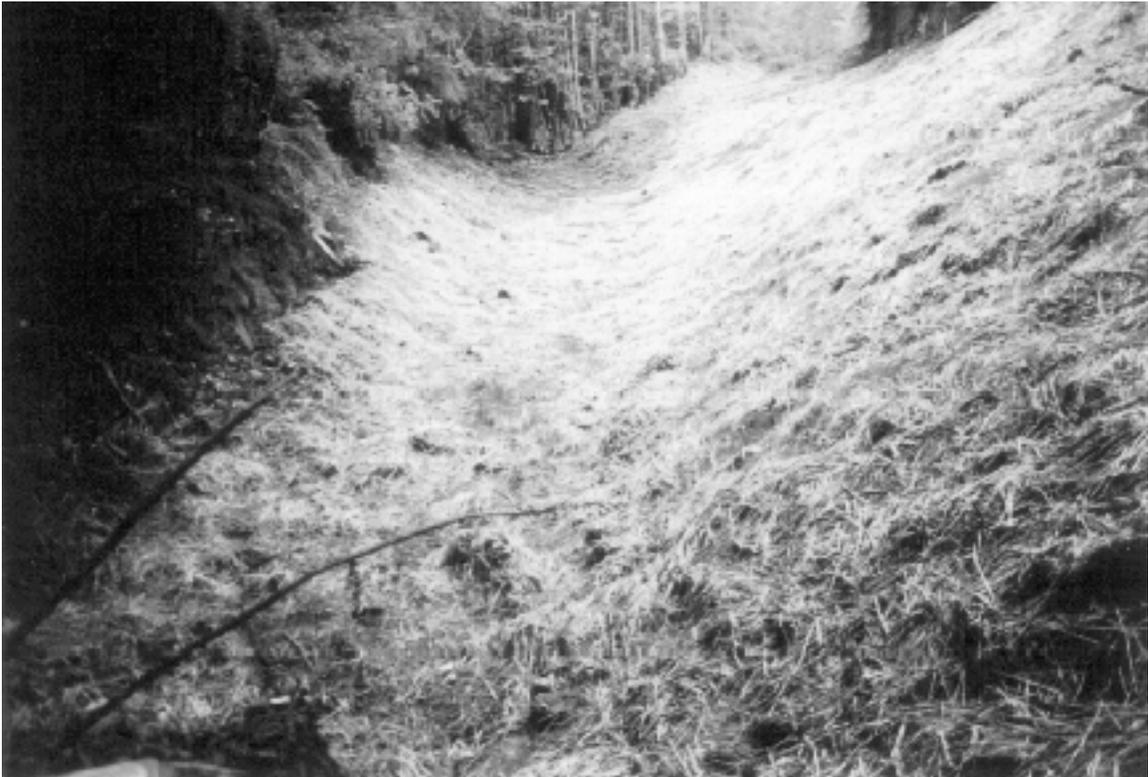
Figure 6. Site 13, B-Line. After treatment photo illustrating the application of in-place outsliping to remove a road. The natural stream channel has been reconstructed by removing all man introduced fill and slash, and now has a 6 foot wide channel bed designed to convey peak flood flows with minimal future erosion.

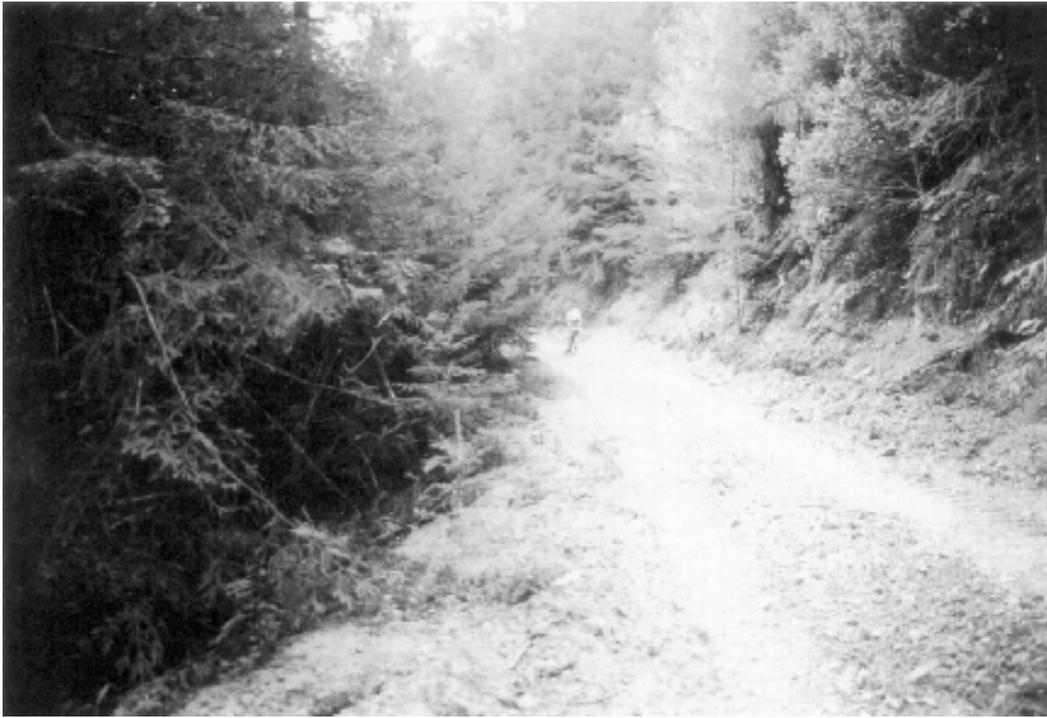
Figure 7. Site 94, G-005-01 Road. Before photo of road reach which exhibits unstable fill slopes between the orange flagging to beyond the person in the photo. A main fish bearing tributary to the South Fork Garcia is located 75 feet downslope of the road, and the potential fill failure was determined to have a risk of delivering some sediment to the stream.

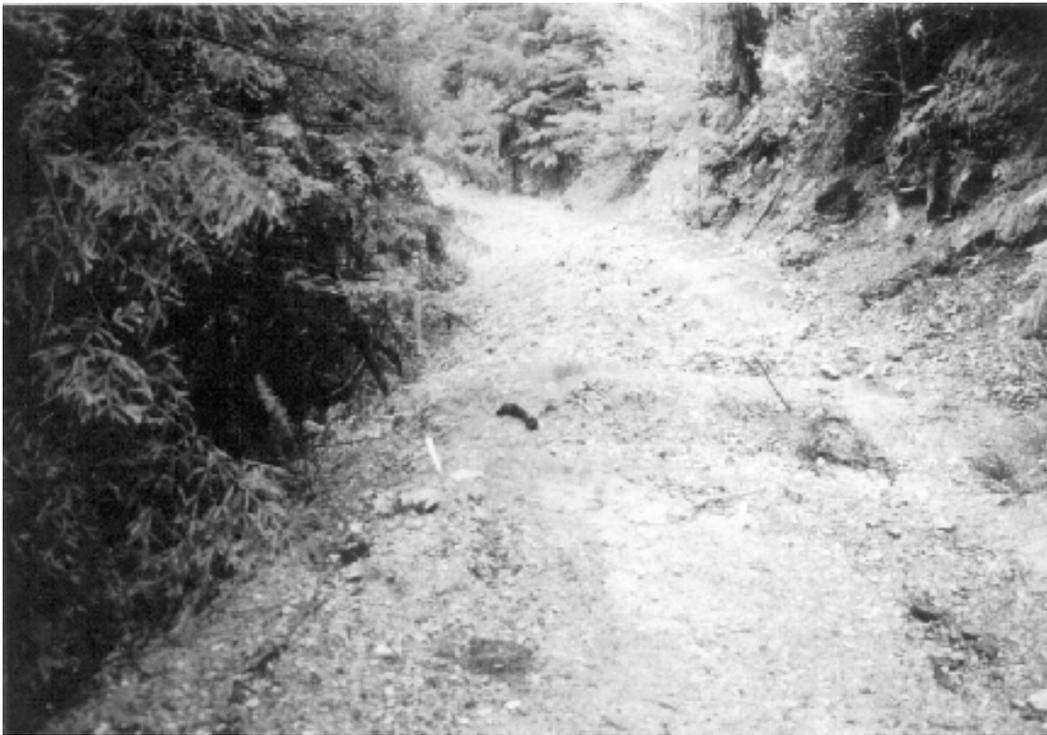
Figure 8. Site 94, G-005-01 Road. After treatment photograph from the same location. The unstable fill slope has been excavated beyond the orange flagging and the spoil material has been placed on the stable portion of the road bed with a prominent outslope. Note how the spoil material now extends to the base of the small conifer on the cutbank in the middle of the photo (the spoil material is nearly 3 feet deep at the former inboard edge of the road). A sizable cross-road drain has been constructed in the foreground of the photo to disperse road runoff.

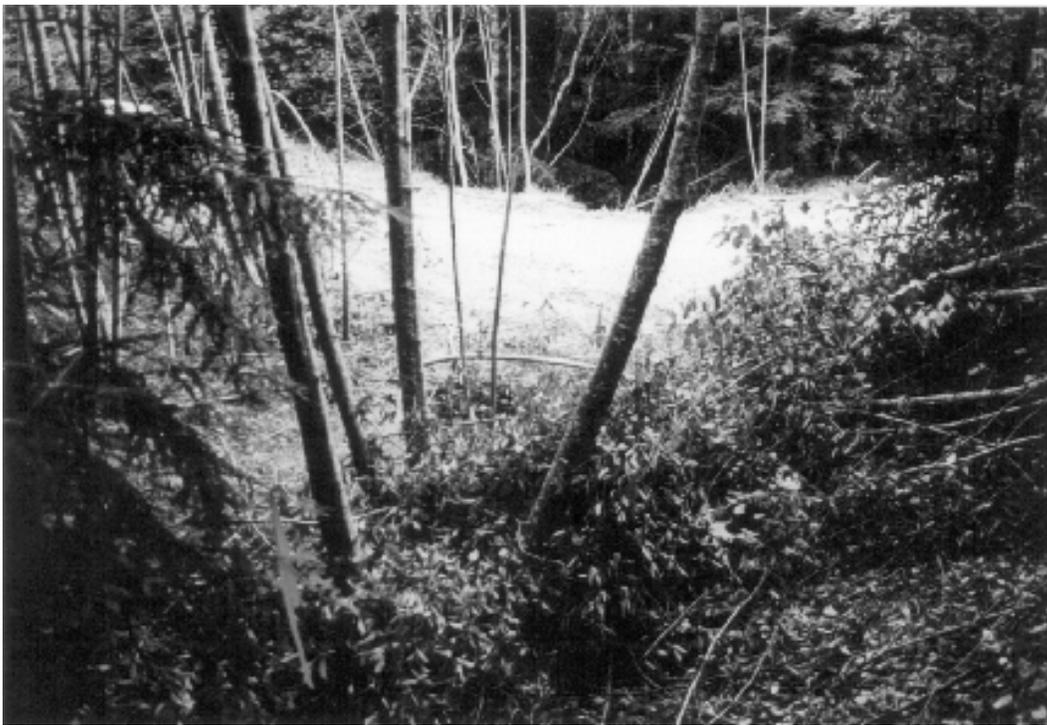
Figure 9. Site 100, G-005-01 Road. Before photo looking downstream at a large stream crossing to be decommissioned or properly pulled. Prior to opening the road to vehicular access, the road was completely overgrown with similarly sized alder as is visible in the photo. The crossing fill was eroding annual as a result of a plugged culvert. Future erosion at the site was estimated to be 525 yds³.

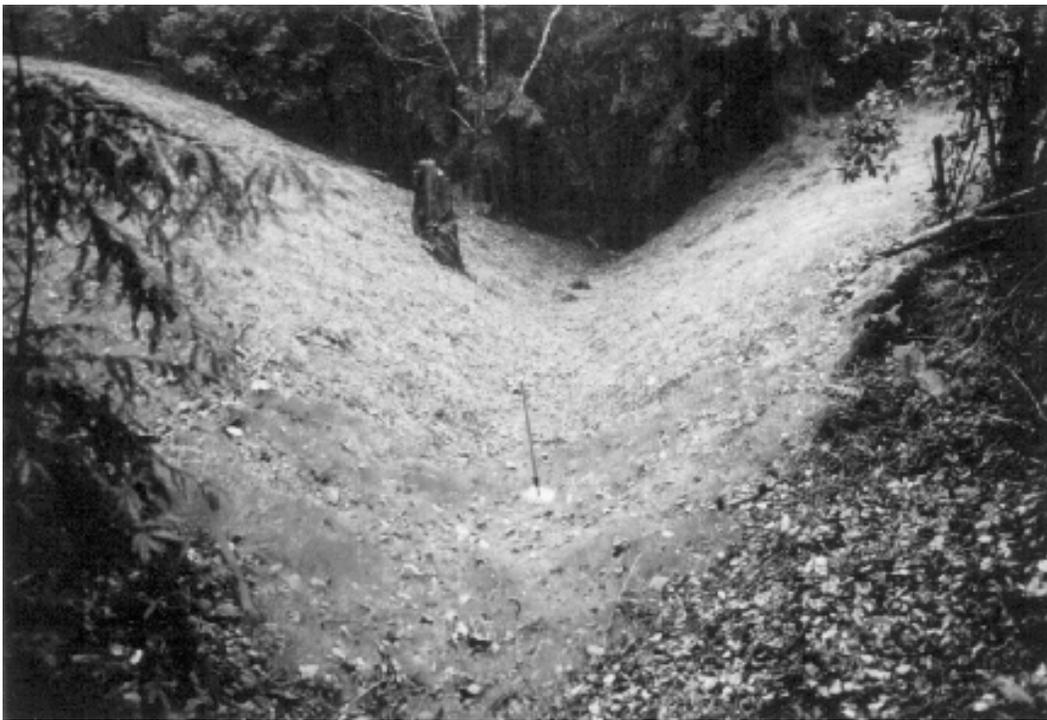
Figure 10. Site 100, G-005-01 Road. After treatment photo looking downstream. Note the orange flagging, redwood branch and leaf litter in the foreground denote the same location. The excavation involved removing over 900 yds³ of fill from the stream crossing. The formerly buried stump helped to define the fill versus native soil material boundary. The channel has a 5 foot wide stream bed and 2:1 sideslopes designed to accommodate peak flood flows.

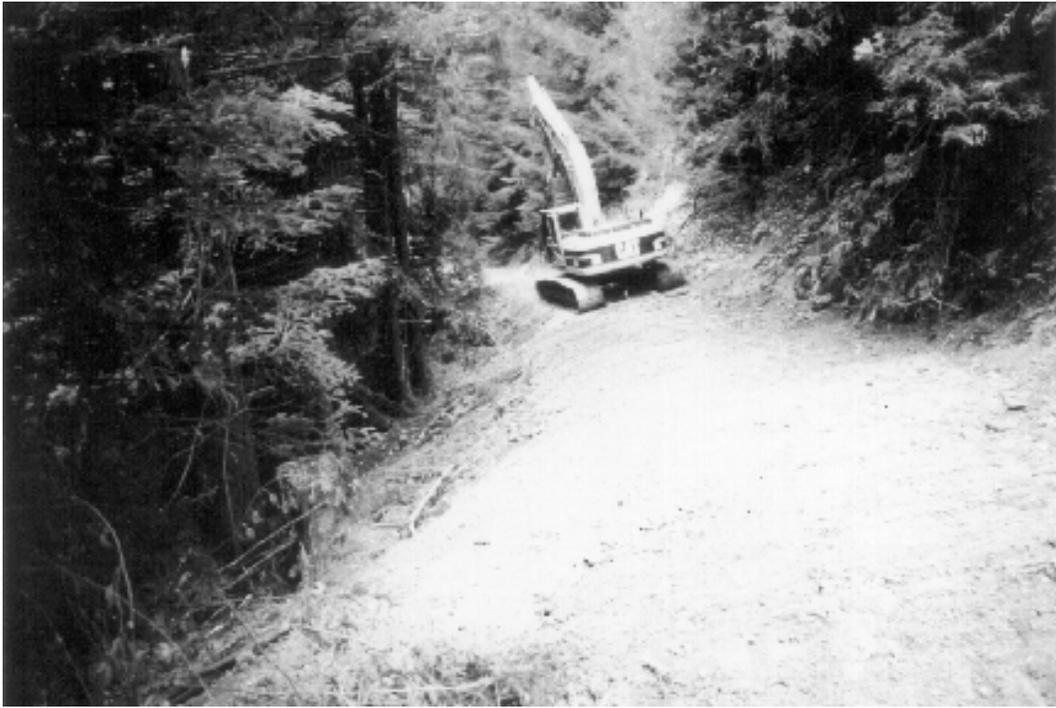
Figure 11. Site 99, G-005-01 Road. After photograph of section of road which has had unstable fill material excavated and placed with an outslope along the base of the cutbank (i.e. in place outsloping). The unstable fill, which posed a risk of sediment delivery to a downslope stream, extended out to the top of the stump prior to the excavation. This stretch of road was decommissioned.

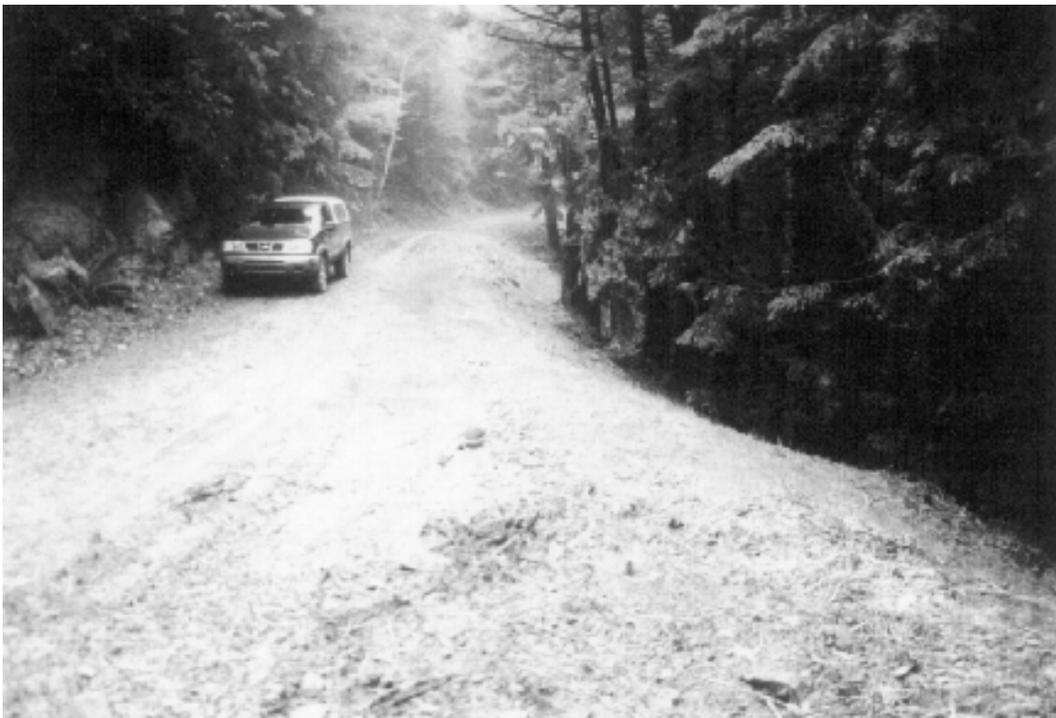
Figure 12. Site 106, G-005-01 Road. This after photograph exhibits the same treatment as in Figure 11 (i.e. excavating unstable fill material along the outside edge of the road), except for the road was not decommissioned but retained for future use. The fill material was excavated and loaded into dump trucks to be hauled to a stable location down the road for permanent storage. In upgrading the road, the road width was lessened, the inboard ditch was filled and eliminated, the road was re-shaped to exhibit a mild outslope with no berms, and periodic rolling dips were constructed along the road bed to ensure dispersed road runoff. Note the rolling dip about 60 feet behind the truck.
