## OBJECTIVES AND PRELIMINARY FINDINGS

Submitted by Jack Monschke  
Contractor/Consultant  
Watershed Management  
April 5, 1989

The following report was prepared by Jack Monschke, Contractor/Consultant, Watershed Management, for R&J Timber Company. Part I of this report states the consultant's objectives and presents a summary of his conclusions. Part II presents a brief account of field work performed from March 12 to March 30, 1989, accompanied by preliminary findings based on the data collected to date. Part III sets forth recommendations intended to improve operations in the future.

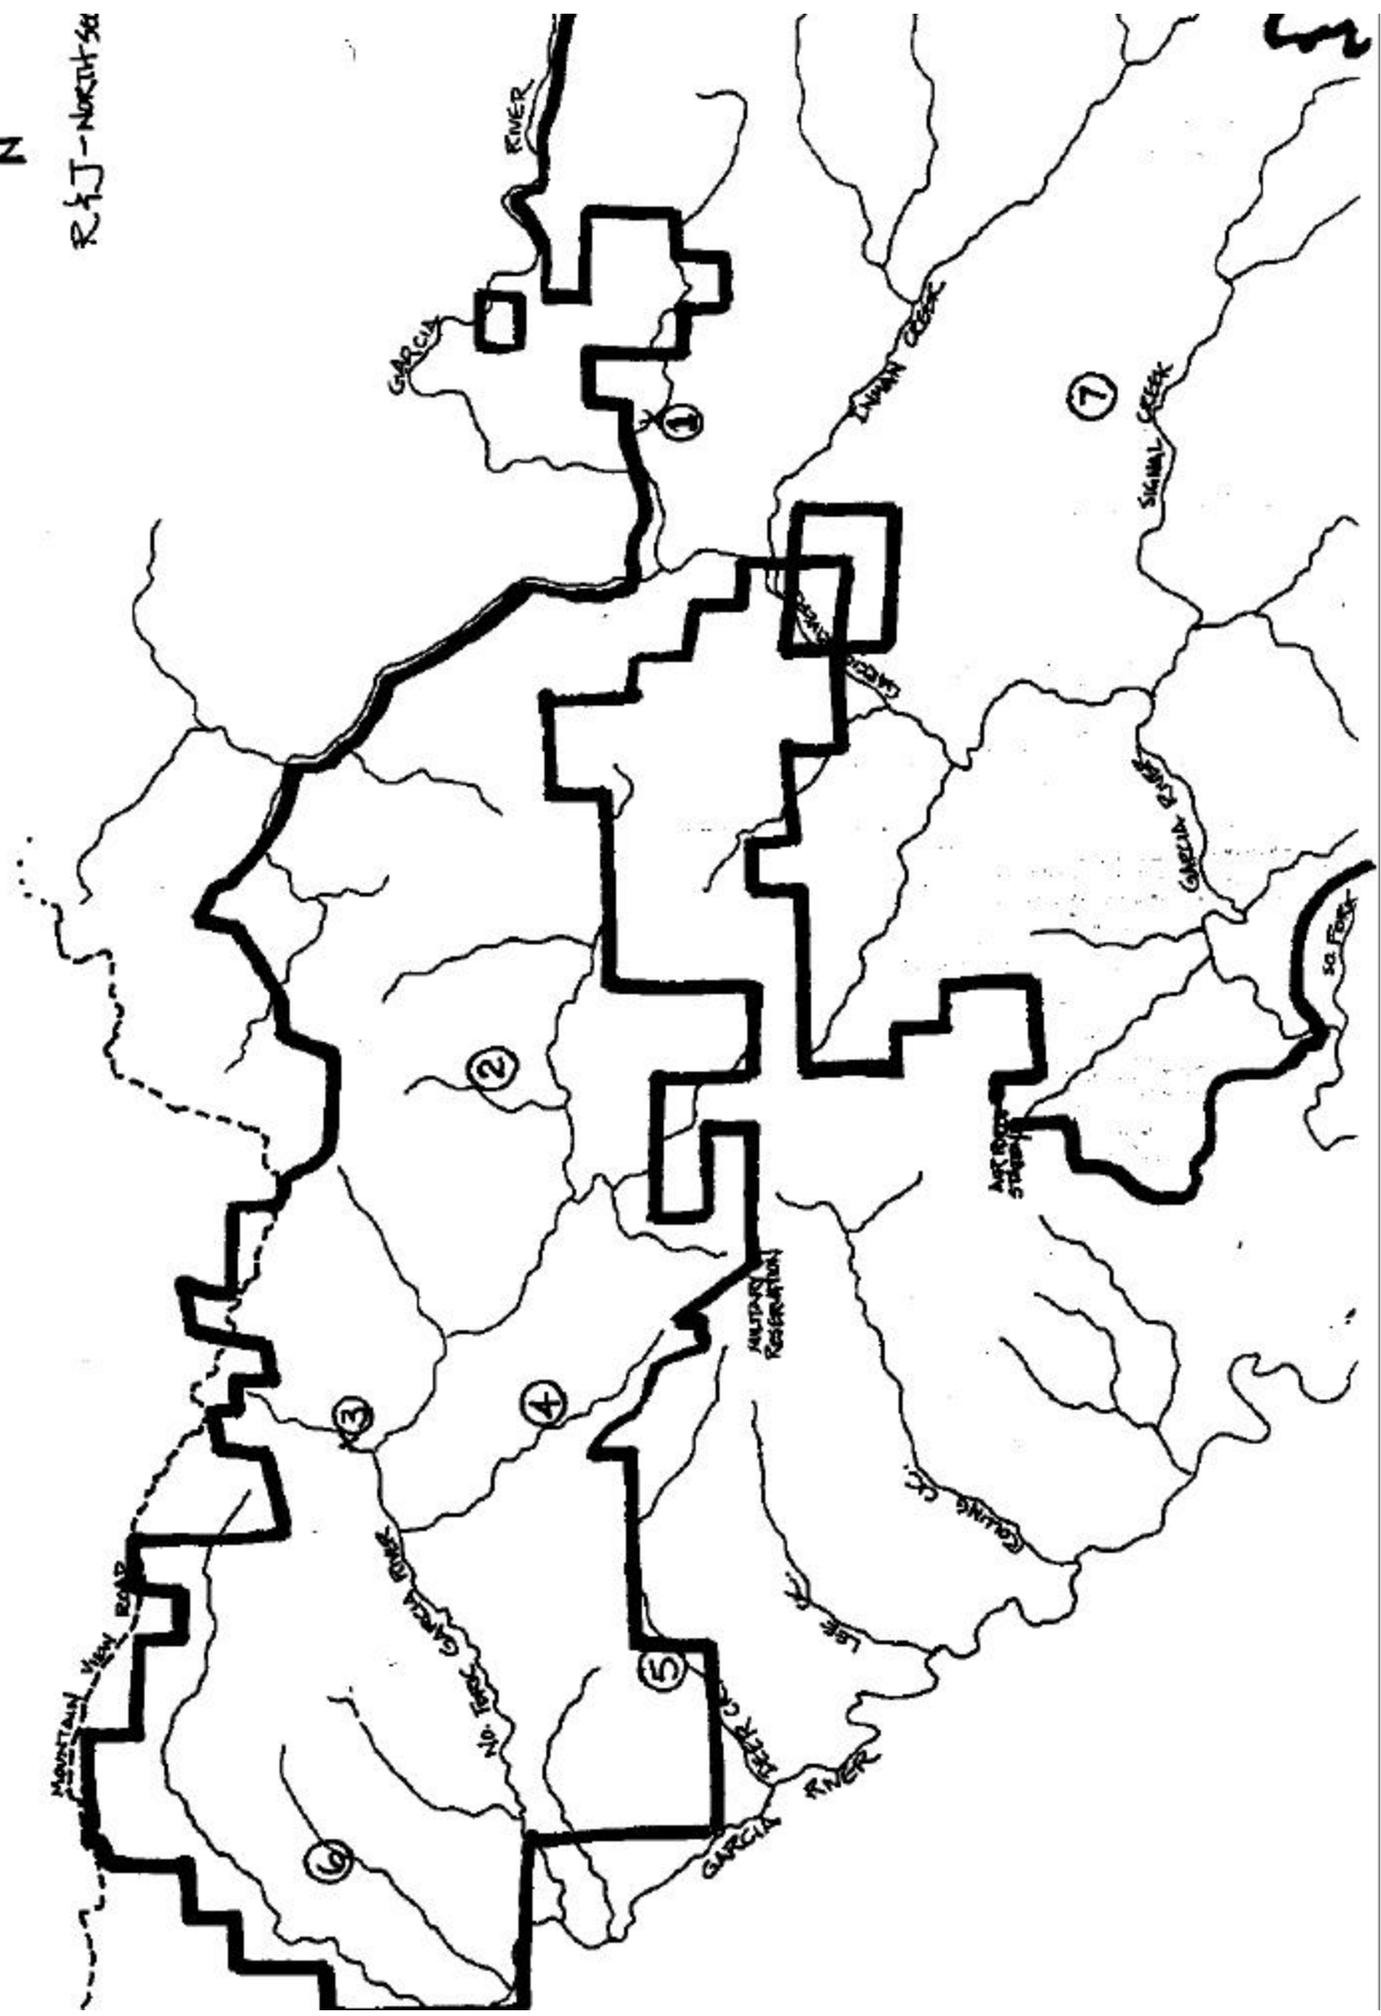
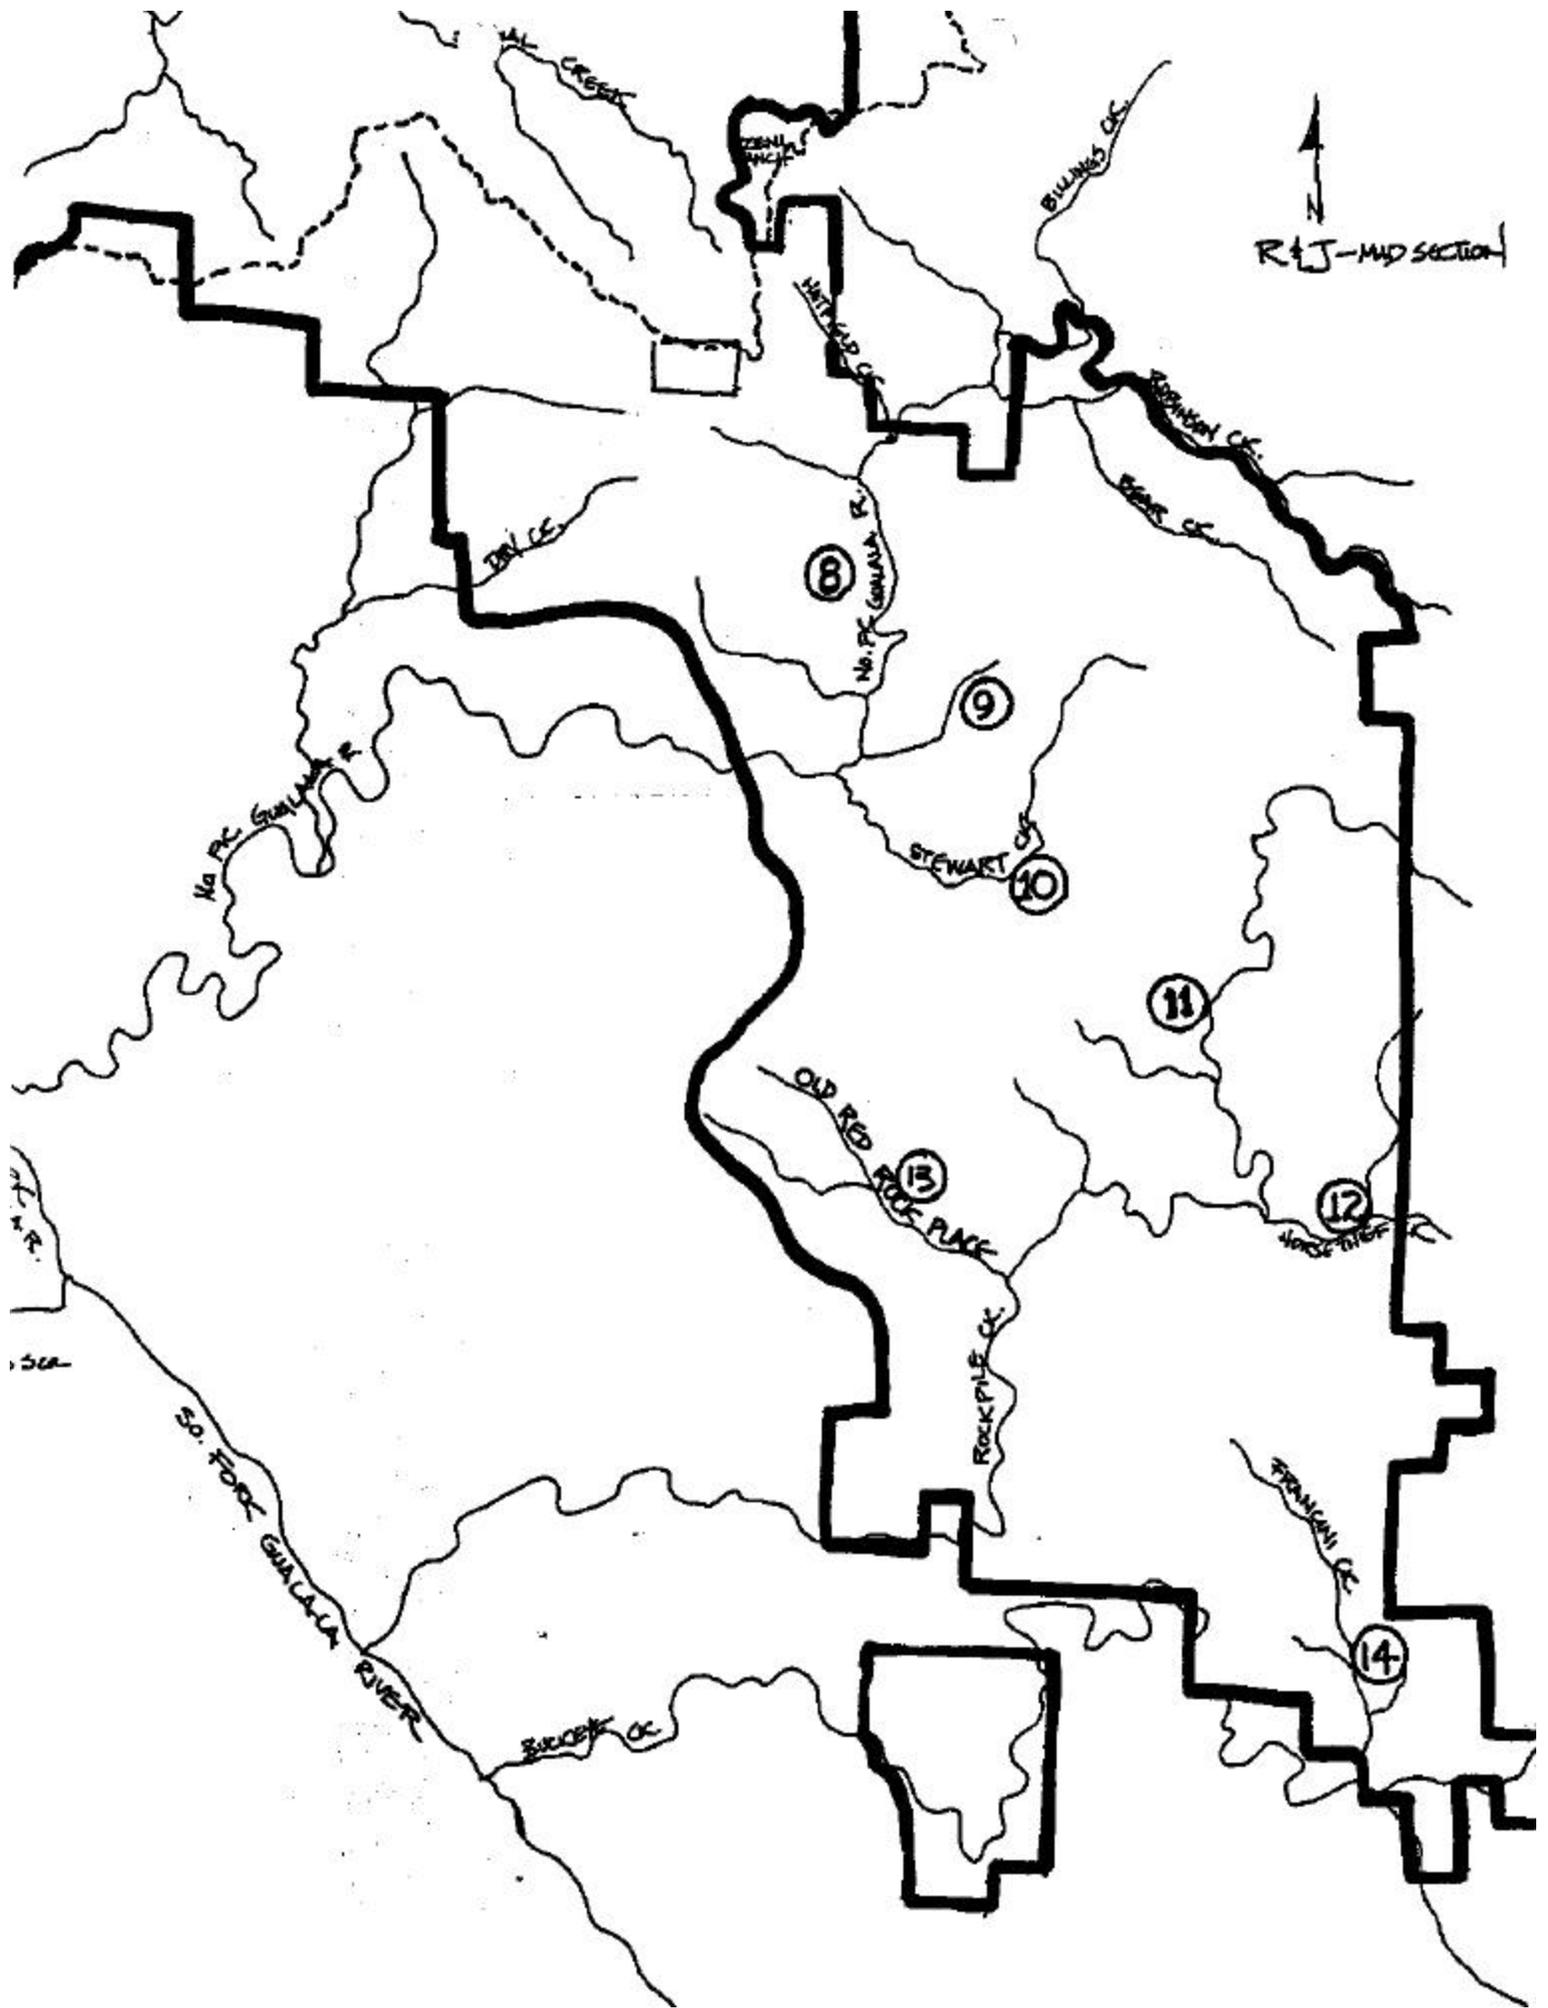
Appendix A  
Flight Notes and Maps

- 1 -- Headwaters Main Garcia. Current R&J winter harvest operation. Streams out of logging area clear, Garcia muddy. Notice an undersized culvert where water was running over on higher flows. This would have muddied the stream on the harvest area. Section 6, T12N, R14W

- 2 -- No. Fork Garcia starting to show color in Section 4, T12N, R15W upstream from Jack's opening. No R&J harvest here. Main tribs running clear and I don't spot any definite source point causing this color.

- 3 -- 38° 55.02'N/123°34.60'W Murky on non-logged area – dirtier than anything coming off logged area. Followed it up to its erosion source point.
- 4 -- About same color as North Fork Garcia. No R&J harvest here but some chance that initial work by R&J to open up future haul road may have contributed some sediment.

- 5 -- Deer Creek -- lots of R&J harvest here on Section 11, but Deer Creek running real clear.
- 6 -- Drainage heavily logged by R&J on both sides, but running clear.

- 7 -- 38° 51.97' N/123° 29' W -- Side drainage on north off Signal Creek. No R&J harvest here but running murky.
- 8 -- Gualala River trib on west side (38° 49.22'N/123° 25.97'W) running murky. No R&J harvest here.

- 9 -- upper fork of small Gualala trib on east side (38° 48.94'N/123° 23.92' W) Lots of R&J harvest here but fairly clear.

- 10 -- Stewart Creek is running murky. Harvest here by R & J. Failure on creek just below road at point where water bar drains road (well-vegetated spot). Also muddy water running down road parallel to Stewart Creek -- Hand work needed.
- 11 -- Rockpile running muddy - No R&J harvest here.
- 12 -- Horsethief running real dirty -- No R&J harvest here.
- 13 -- Old Red Rock place - dirtiest side creek so far. No R&J harvest here.

- 14 -- Francini Creek murky -- No R&J harvest here.
- 15 -- Both forks of Soda dirty. R&J harvest summer 1988. I need to identify source on ground.
- 16 -- Fuller Creek two upper forks murky. Main fork really dirty. No R&J harvest here. (38° 41.84 N/123° 16.90'W)
- 17 -- Wheatfield Fork of Gualala muddy. No R&J harvest here.
