**STREAM INVENTORY REPORT**  
**LITTLE NORTH FORK GUALALA RIVER**

*Prepared for:*  
**GUALALA REDWOODS**  
P.O. Box 197  
Gualala, CA 95445

*Prepared by:*  
Dan Gale  
**ENTRIX, Inc.**  
590 Ygnacio Valley Road, Suite 200  
Walnut Creek, CA 94596

**March 28, 1995**

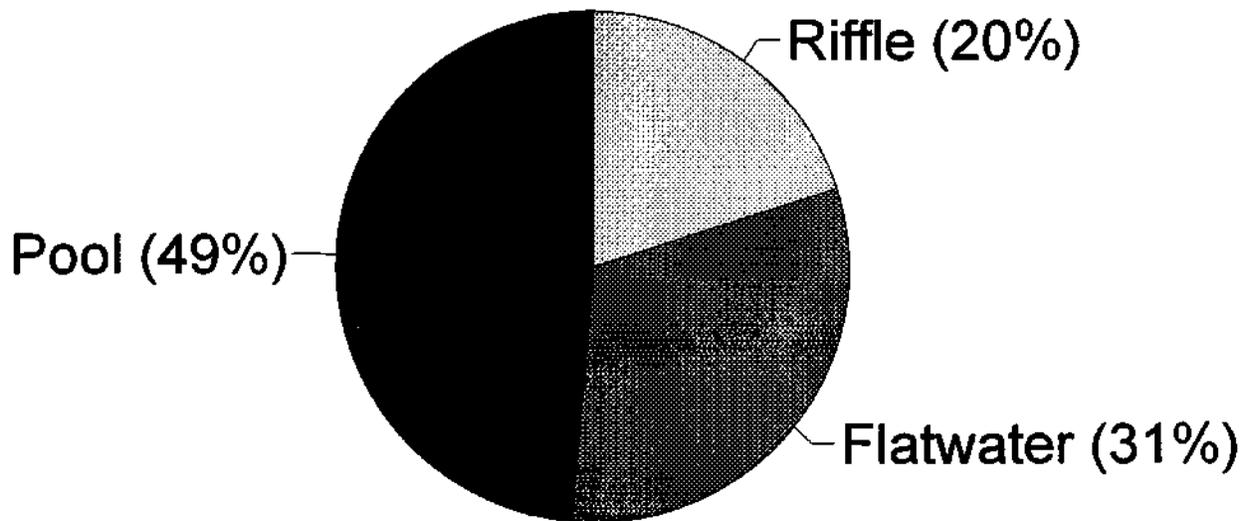
**Figure 1. Little North Fork Gualala River  
Habitat Types by Percent Occurrence**

Table 1 summarizes the Level II riffle, flatwater, and pool habitat types. By percent occurrence, pools made up 49%, flatwater types 31%, and riffles 20% (Figure 1). Pool habitat types also made up 49% of the total survey length, while flatwater types comprised 42%, and riffles 10% (Figure 2).

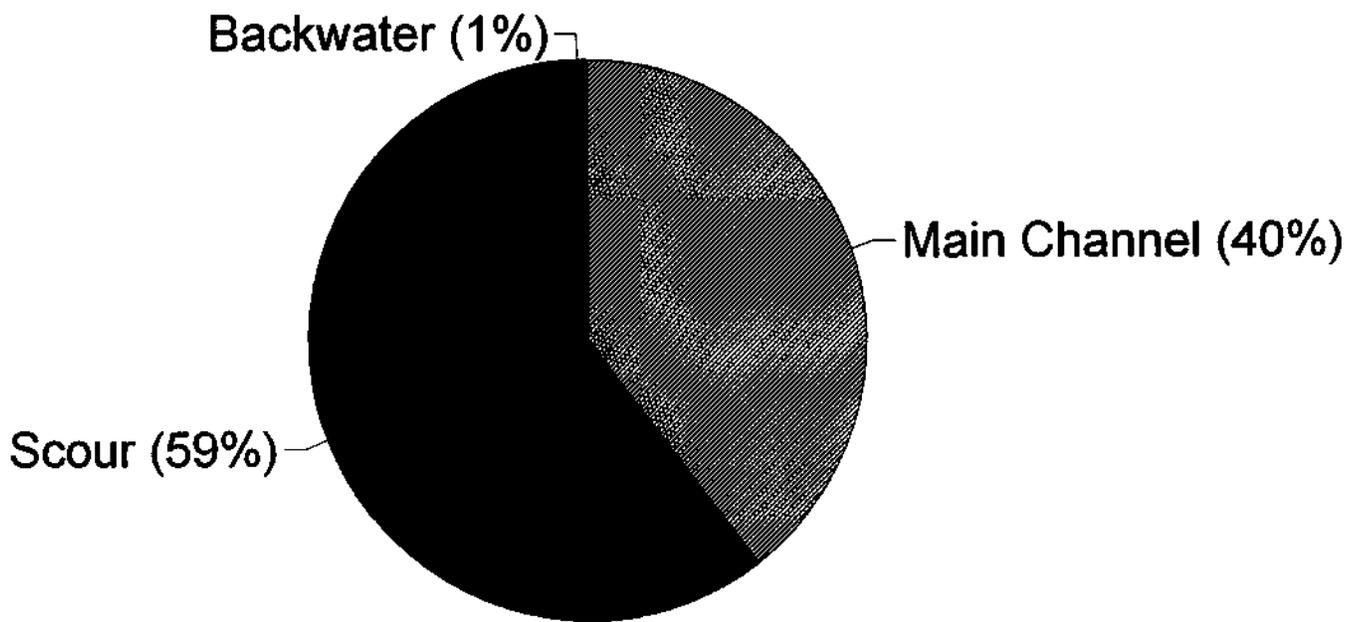
**Figure 4. Little North Fork Gualala River  
Pool Types by Percent Occurrence**

A total of 172 pools were identified (Table 3). scour pools were most often encountered at 59%, and comprised 49% of the total length of pools (Figure 4). Mid-channel pools accounted for 40% of the pools encountered, yet they comprised 50% of the total length of pools.

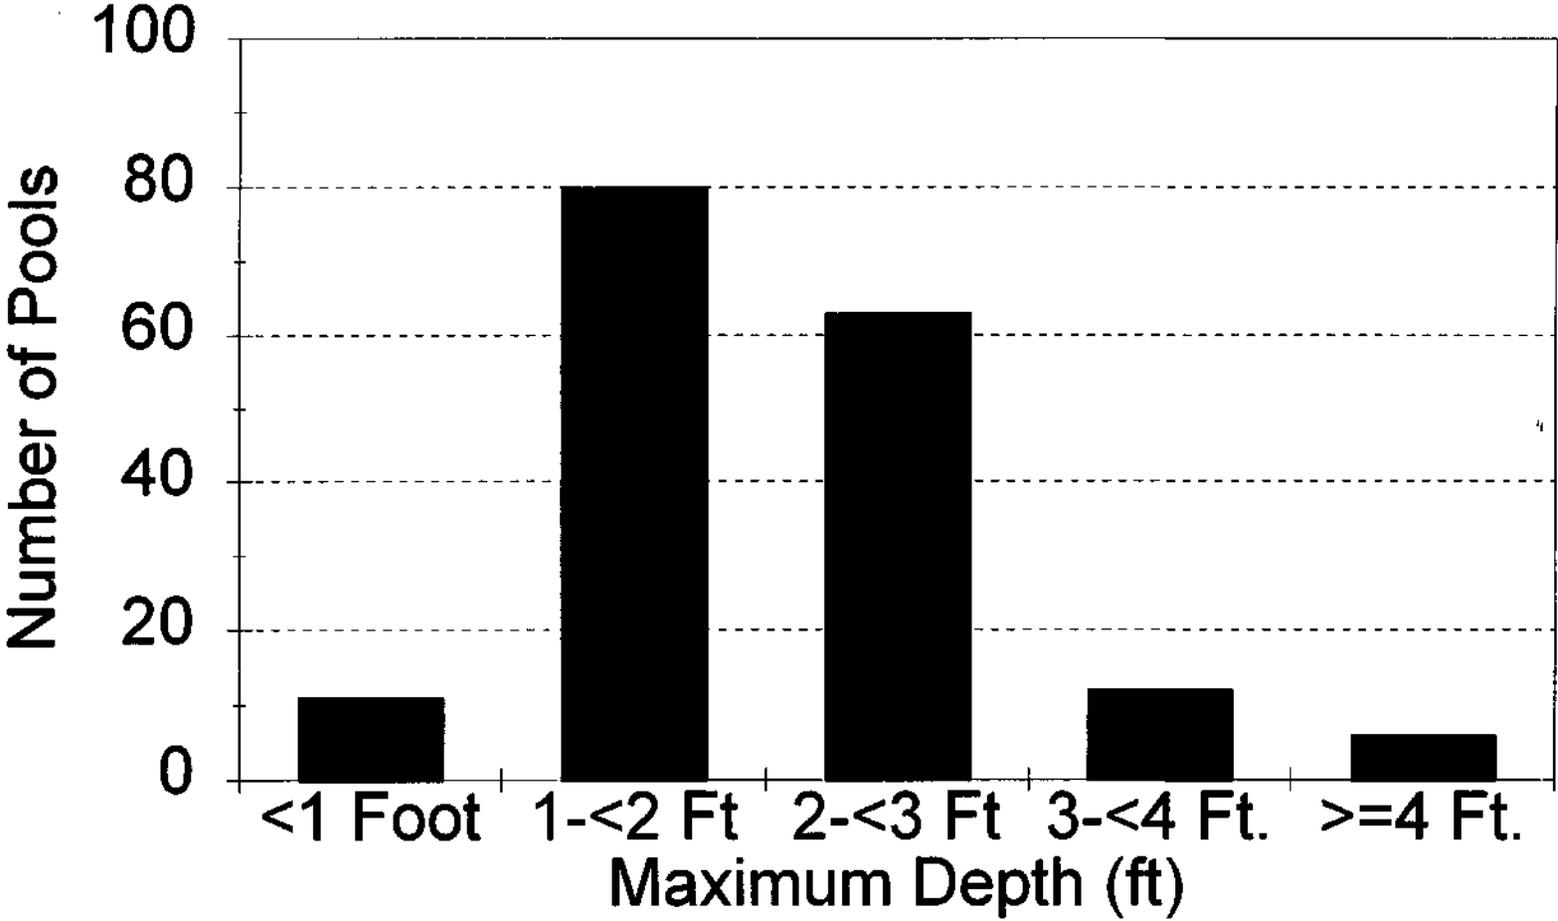
**Figure 5. Little North Fork Gualala River  
Total Pools by Maximum Depth**

Table 4 is a summary of maximum pool depths by pool habitat types. Depth is an indicator of pool quality. Eighty-one of the 172 pools (47.1%) had a depth of two feet or greater (Figure 5).

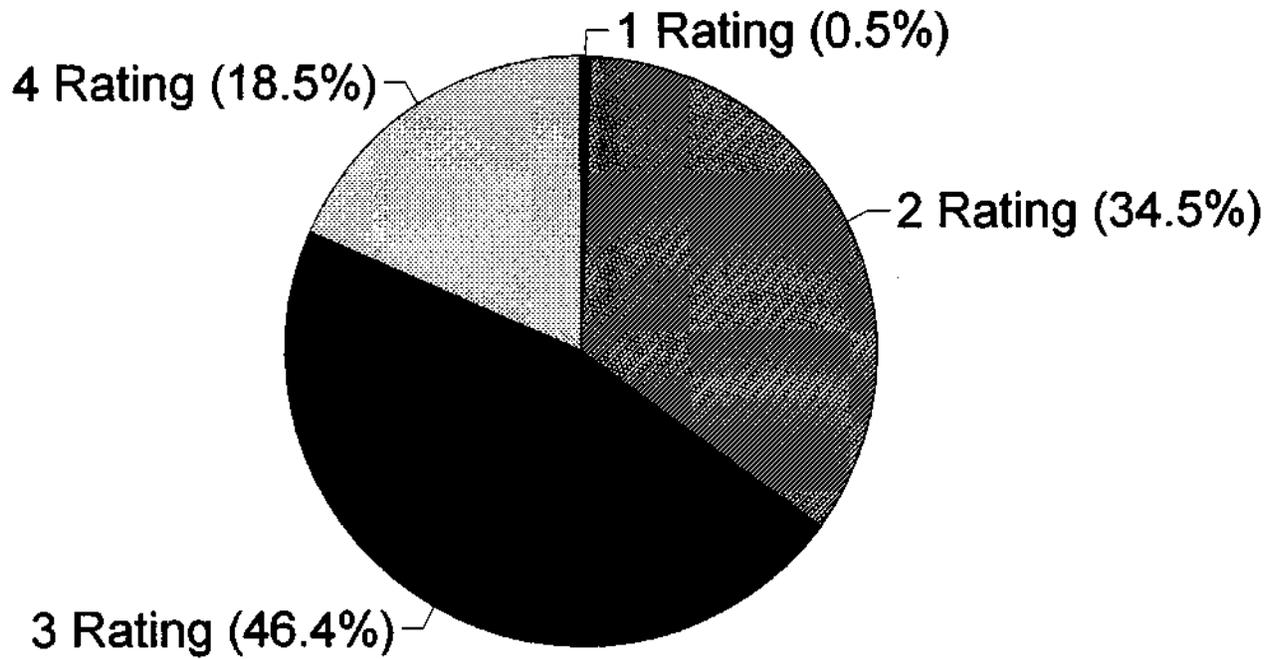
# Figure 6. Little North Fork Gualala River Pool Tail-out Embeddedness

The substrate embeddedness was estimated at main and scour pool tail-outs. Of the 168 pool tail-outs measured, one had a value of 1 (0.5%); 58 had a value of 2 (34.5%); 78 had a value of 3 (46.4%); and 31 had a value of 4 (18.5%). On this scale, a value of one is the best for fisheries (Figure 6).

Of the 168 pool tail-outs measured, 109 had embeddedness ratings of 3 or 4. Only one had a 1 rating. Cobble embeddedness measured to be 25% or less, a rating of 1, is considered best for the needs of salmon and steelhead. In the Little North Fork Gualala River, sediment sources should be mapped and rated according to their potential sediment yields, and control measures taken.

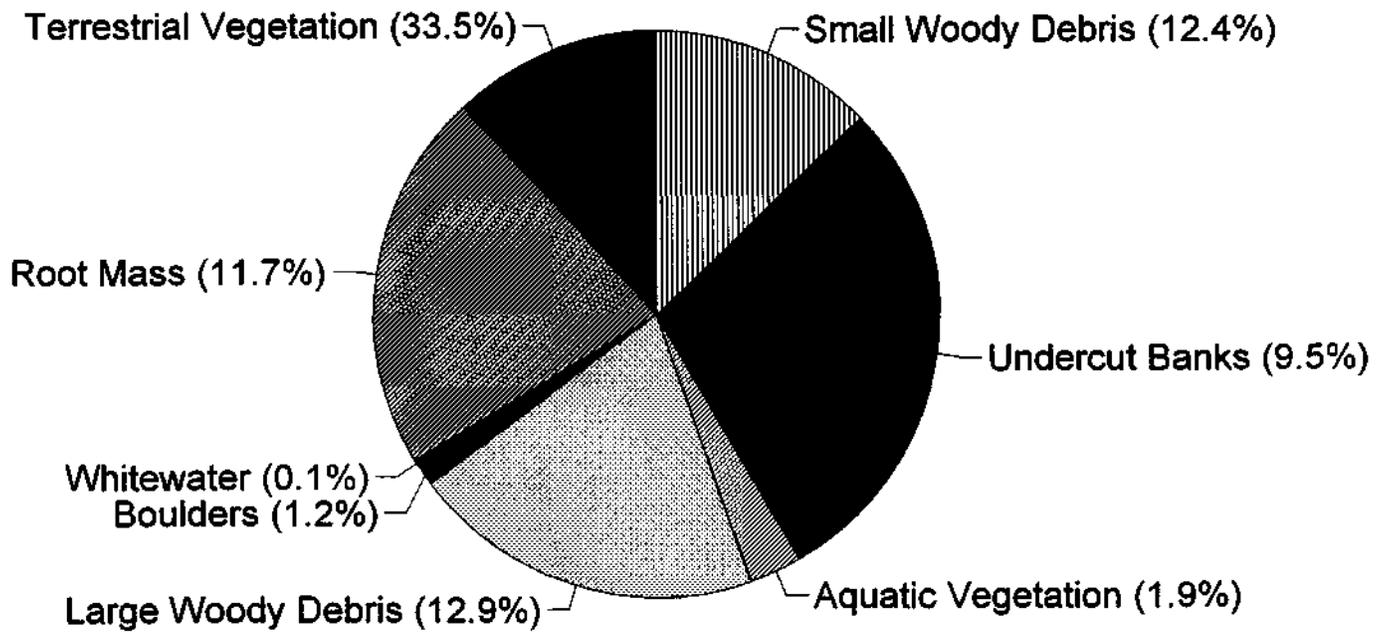
# Figure 7. Little North Fork Gualala River Pool Cover by Cover Type

Table 5 summarizes mean percent cover by habitat type. Undercut banks and terrestrial vegetation are the dominant cover type in the Little North Fork Gualala River, with root masses, large woody debris, and small woody debris comprising the subdominant cover types. Figure 7 describes the pool cover in the Little North Fork Gualala River.

- 5) Increase woody cover in the pools and flatwater habitat units where it is not already present. Adding high quality complexity with woody cover is desirable and in some areas the material is at hand.

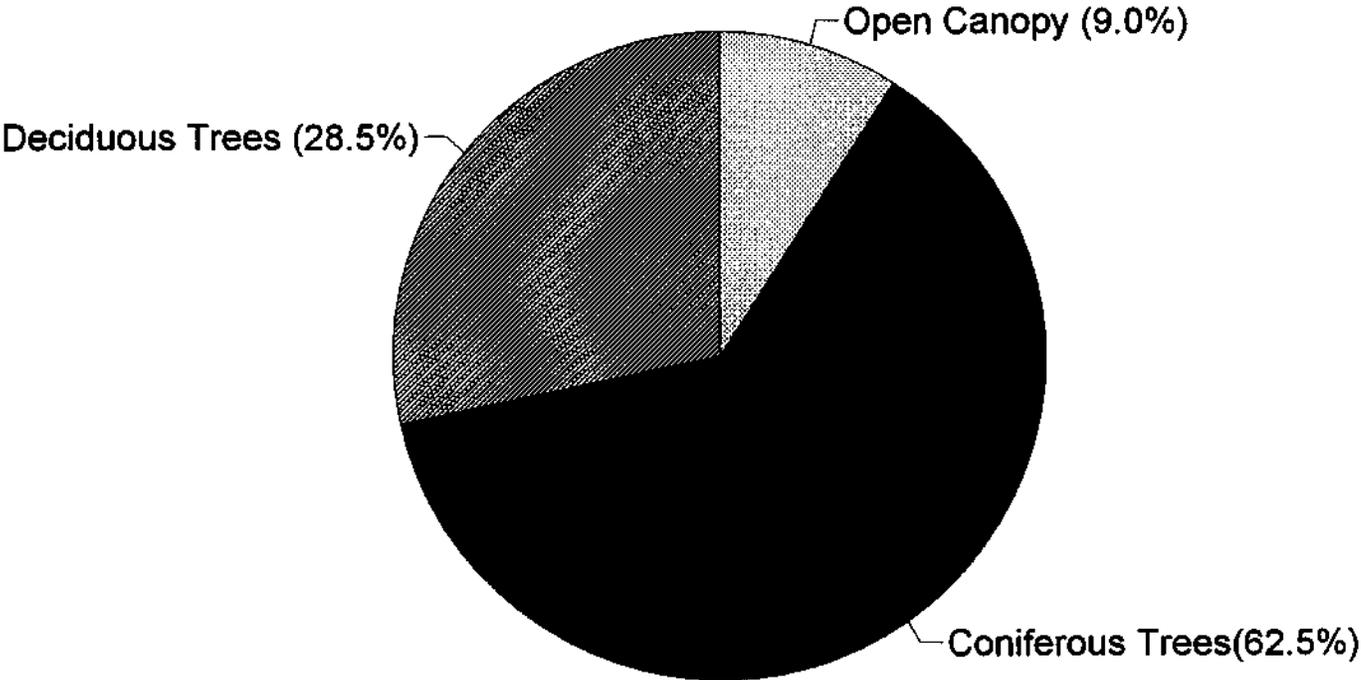
# Figure 9. Little North Fork Gualala River Canopy Composition

The mean percent of open canopy for the entire portion of the stream surveyed was 9.0%. Of the 91.0% of the stream covered with canopy, 31.3% was composed of deciduous trees, and 68.7% was composed of coniferous trees. Figure 9 describes the canopy composition in the Little North Fork Gualala River.

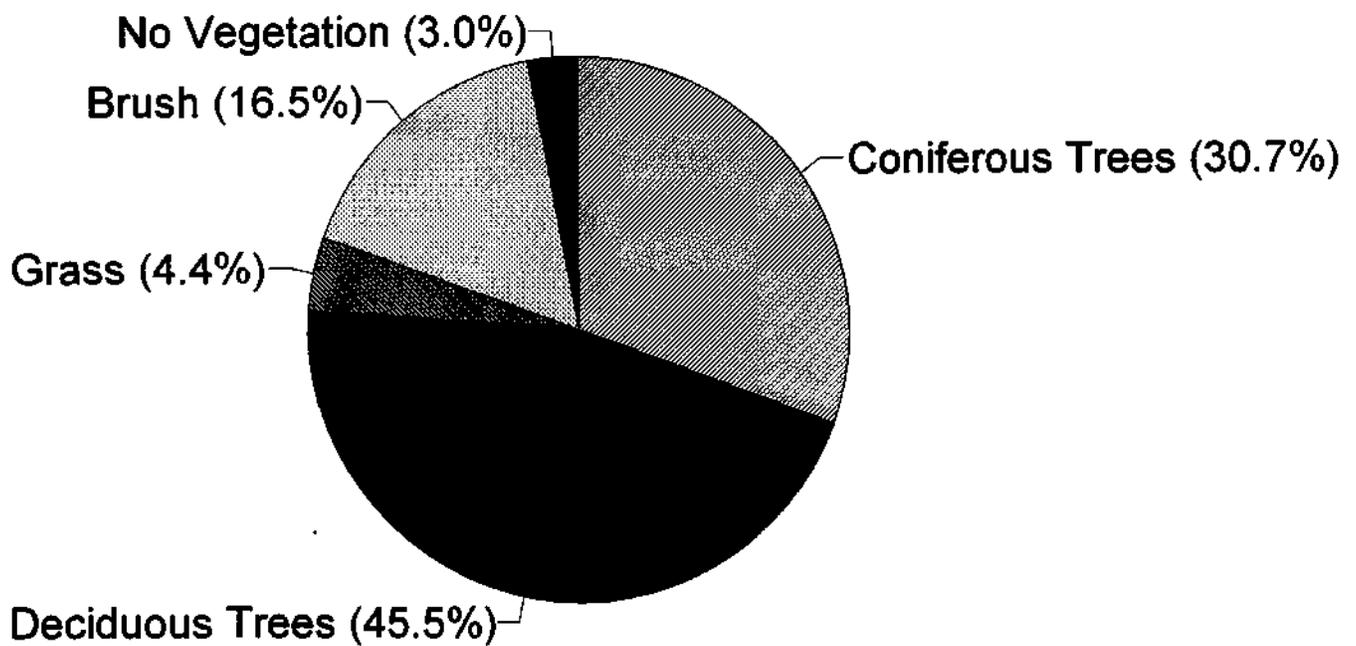
**Figure 10. Little North Fork Gualala River Bank Composition by Dominant Vegetation Type**

Table 2 summarizes the mean percentage of the right and left stream banks covered with vegetation by habitat type. For the stream reach surveyed, the mean percent right bank vegetated was 50.2%. The mean percent left bank vegetated was 50.5%. The dominant substrate elements composing the structure of the stream banks consisted of 0.6% boulder, 39.1% cobble/gravel, and 60.3% silt/clay/sand, with no bedrock encountered in any of the survey reaches. Additionally, 45.5% of the banks were covered with deciduous trees, and 30.7% with coniferous trees, including downed trees, logs, and root wads (Figure 10).
