CALIFORNIA DEPARTMENT OF FISH AND GAME STREAM SURVEY

NAME.....Horse Creek.....COUNTY..... Mendocino.....
 STREAM SECTIONentire.....FROM.....mouth.....TO....headwaters.....LENGTH..3.5 mi.....
 TRIBUTARY TO.....Rancheria Creek.....TWP.....13N...R...15W...SEC.....1.....
 OTHER NAMES.....none known.....RIVER SYSTEM.....Navarro River.....
 SOURCES OF DATA.....personal survey.....

Horse Creek

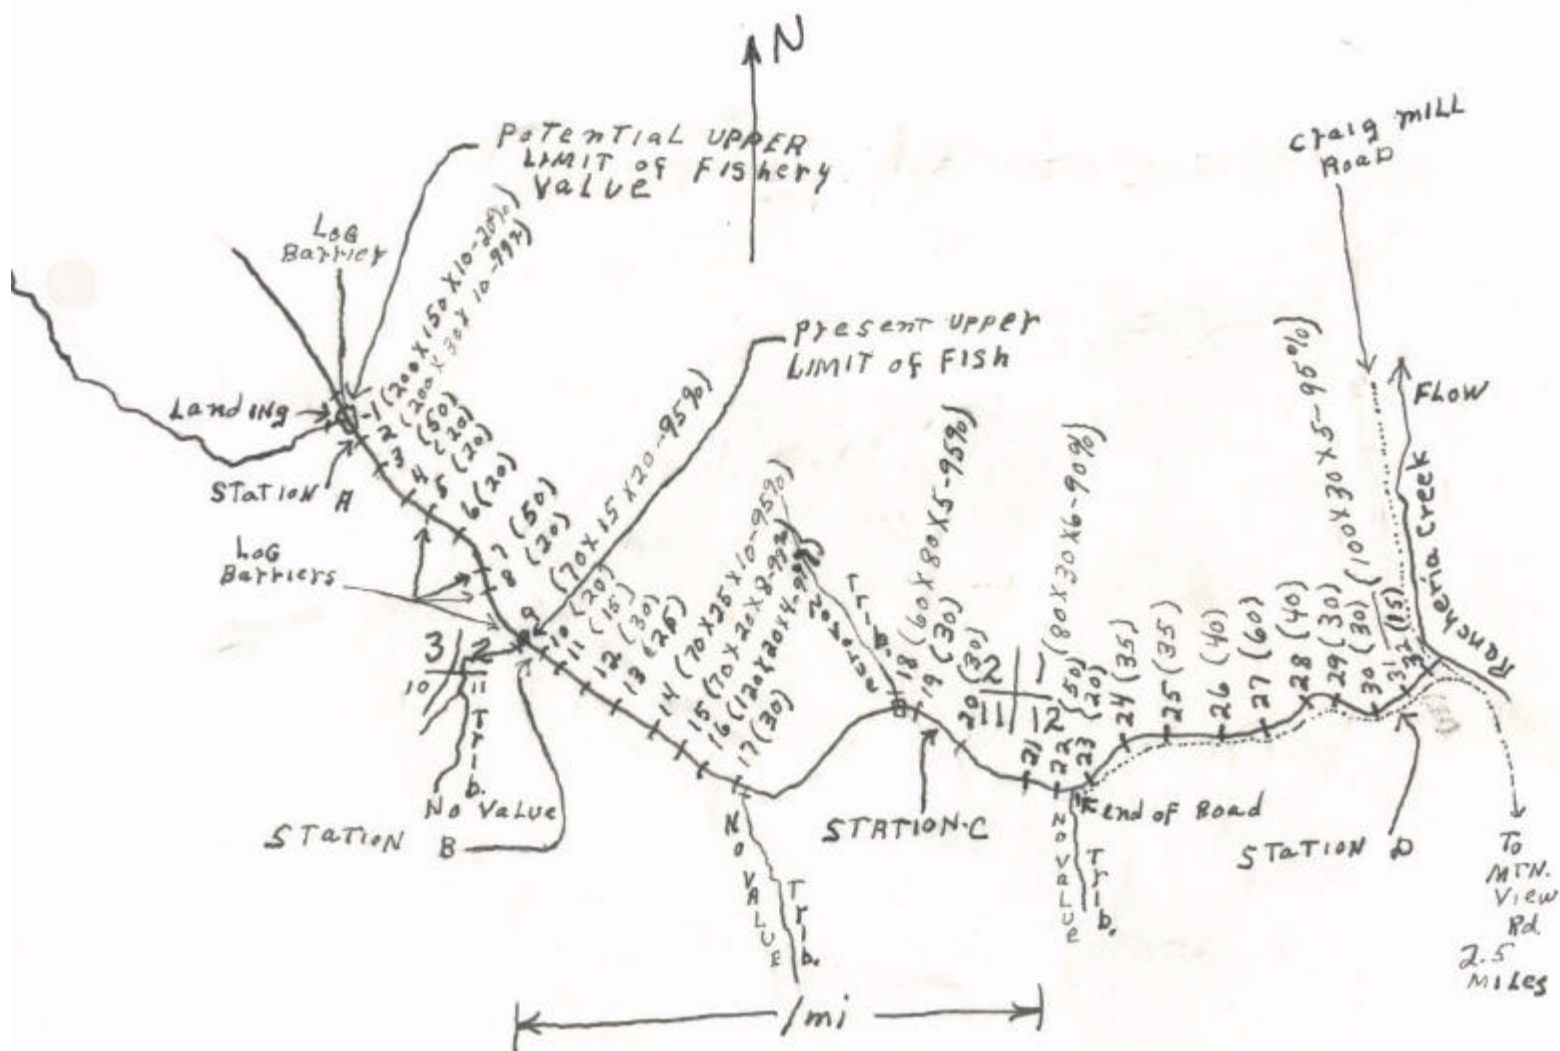
SKETCH MAP - See attached.

Barriers - See attached map for barrier locations, sizes and numbers.

Other Remarks - Fish were seen up to barrier No. 9 located just above Station B on the map. Very few fish were found between Station B and C, evidently from the standpoint of very open to long riffle areas. Station C to the end of the road had more fish present in this area, and from the stream section road to mouth, less fish were observed again. The ratio of roach and rainbow trout/steelhead are as follows: 75% roach to 25% RT-SH. Only 10 five-inch RT-SH were seen. The upper area between Station B and Station C, the numbers of fish observed were 5 for average pool with 5 per 50 yds riffle area and are considered scarce. The middle area between Station C and the end of the road averaged 25 to 50 fish per 100 yds of riffle and stream area with 25 to 35 per average pool observed. The lower area between the end of the road and the mouth averaged 15 to 25 fish per 100 yards stretch of riffle and stream with 15 to 20 fish per average pool.

Add 15% For debris
between Jams not listed
