THE RESOURCES AGENCY OF CALIFORNIA
Department of Fish and Game

STREAM SURVEY

Date: May 25 and 31, 1977

NAME: Unnamed Stream (Tributary to Sonoma Creek) COUNTY: Sonoma

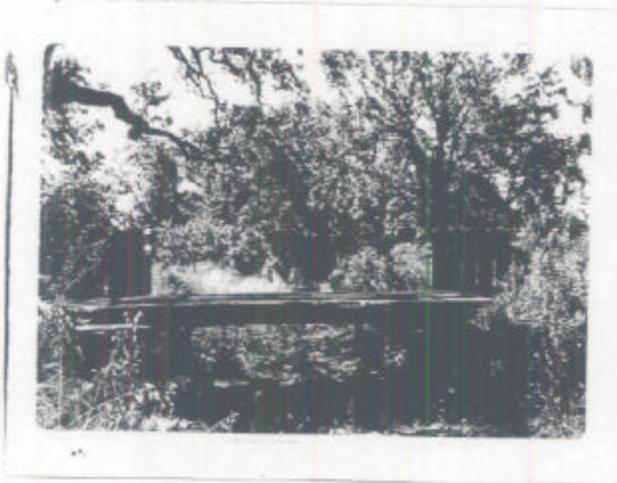
5

- 5. Culvert under driveway at 7660 Sonoma Highway. Dimensions: 3 X 8 feet north
No floor. 3 X 10 feet south
- 6. culvert under dirt road at 7676 Sonoma Highway. Dimensions: 6 X 10 feet.
No floor.
- 7. Wire mesh (4x4 inches) fence ^{across} ~~in~~ stream behind 7700 Sonoma Highway.
- 8. Culvert under dirt road at 7700 Sonoma Highway. Dimensions: 3 X 6 feet.
No floor.
