Final Report

**Fiock Dam Removal**

June 2001

Great Northern Corp.  
PO Box 20  
Weed, CA 96097

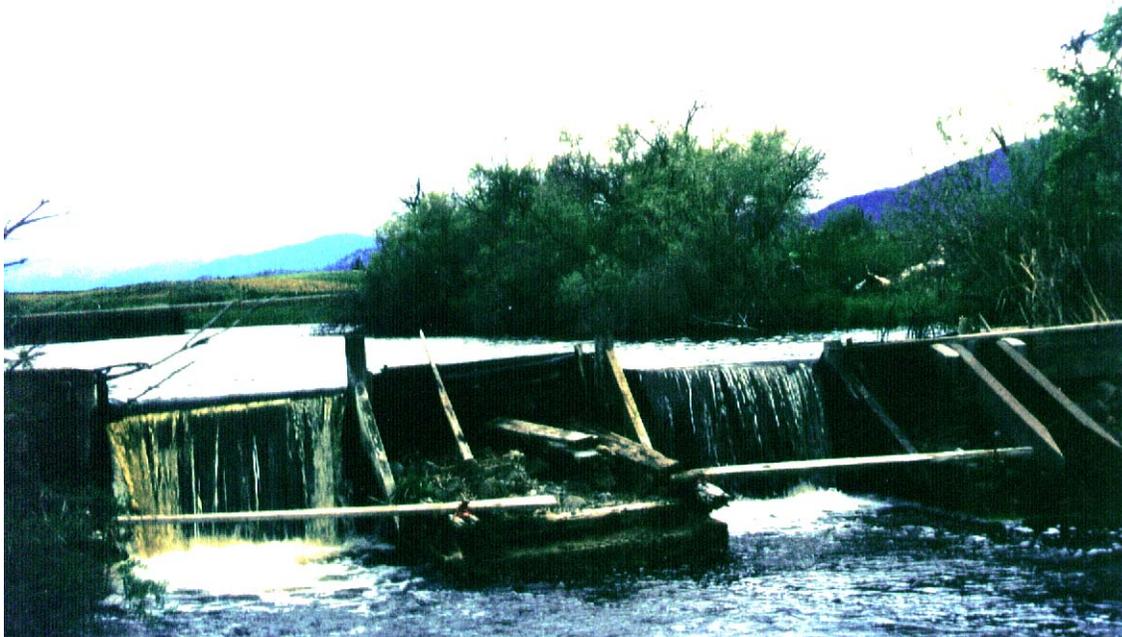
Fiock dam, summer, 1992

Meanwhile, the NRCS offered to develop a design and possible cost share for a new dam to replace the existing structure that clearly was in need of major repair. That would provide the Fiocks with a long-term irrigation diversion system that would be both reliable and cost effective in terms of water delivered, but wouldn't do much for fish or water quality.

Meanwhile, the Fiocks were faced with tough choices. They hoped for fallback system--a new dam--was not going to be. Their old dam structure had continued to deteriorate, and was clearly unsuitable for further service without a substantial investment of time and money. With the ESA, permits for the necessary repair work looked problematic, and in any case they were short handed, and could hardly afford the time it would take during their busiest season.

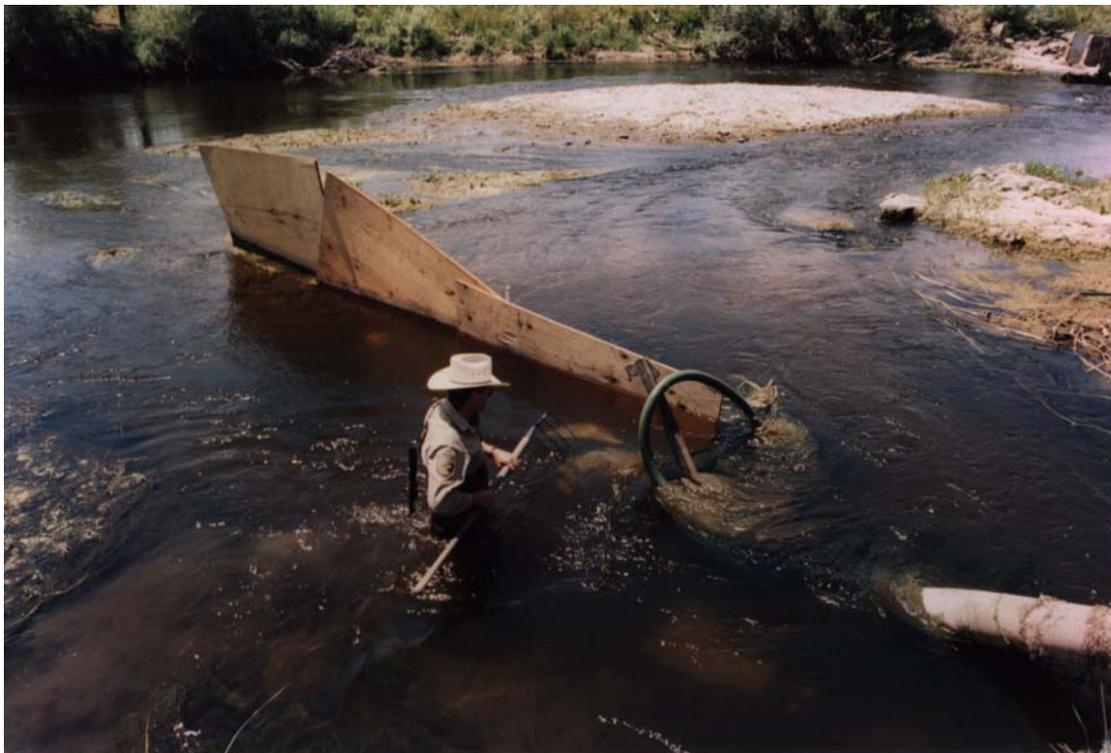
The DFG-supplied screen and pump performed reasonably well the first season, although it did require significant hands-on efforts by the DFG fisheries biologist assigned to the Shasta who assumed primary responsibility for its successful operation. In subsequent years, changes in the river channel and aquatic vegetation in the vicinity of the screen resulted in rapidly escalating requirements for hand cleaning of the screen to remove filamentous algae, re-starting of the pump following loss of prime due to screen clogging, and a generally unsatisfactory service record. Ultimately its unreliability resulted in visible losses in hay production for the Fiocks, a situation well noted by other ranchers throughout the Shasta Valley.

Jim Whelan, CDFG helping the self cleaning screen get clean (again).

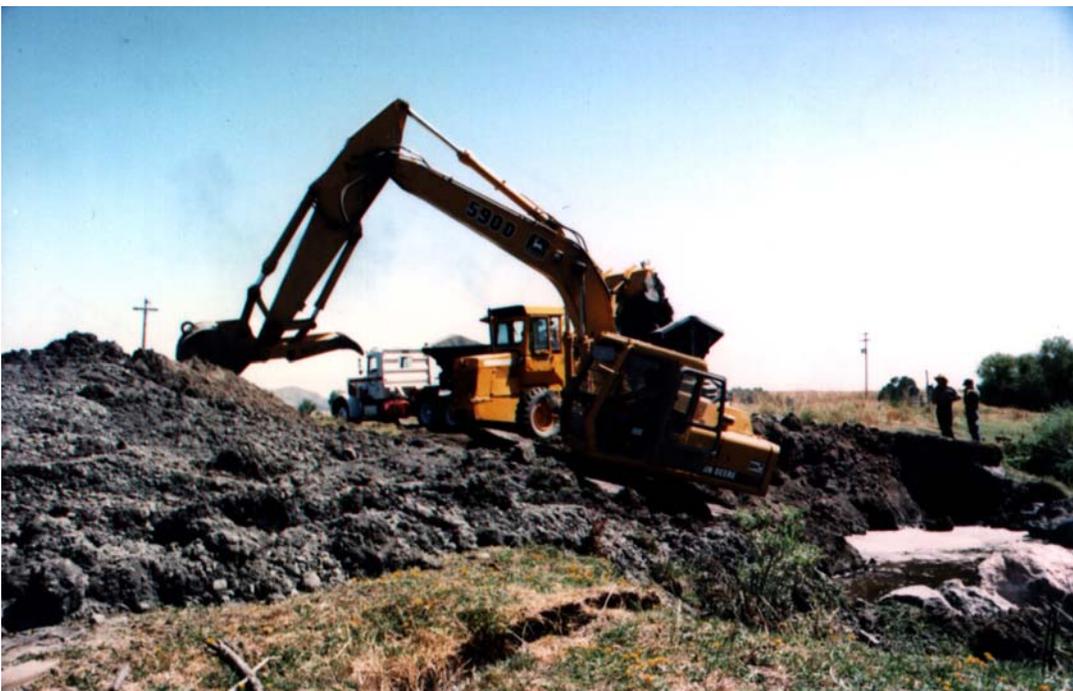
As excavation work on the infiltration gallery began, things began to go wrong. In this area of the Shasta Valley, there is a silica cemented hard pan layer down about 10 feet below the surface, which cannot be dug through. It forms the bottom of the river, and the maximum depth of our infiltration gallery. On top of this hard pan is a three-foot layer of sand and gravel which at the time was entirely below the water level of the river. Above that was about six feet of sandy silt soil. The soil could be readily removed, but once excavation began in the sand and gravel layer, it would liquefy and flow as a slurry from the edges to the center of the hole. As it flowed inwards, it undermined the edges of the excavation, and causing the overlying six feet of soil to break off in large chunks and fall into the hole.

We enlarged the hole, hoping that an angle of repose could be established that would allow the banks to be stabilized, yet still allow us to remove all the sand and gravel resting on the hard pan layer. It soon became apparent that the sand and gravel slurry was so liquid that it would never stabilize until long after the hole was so big that the excavator would no longer be able to reach the center of the hole.

Pile of excavated material grows as infiltration gallery is constructed

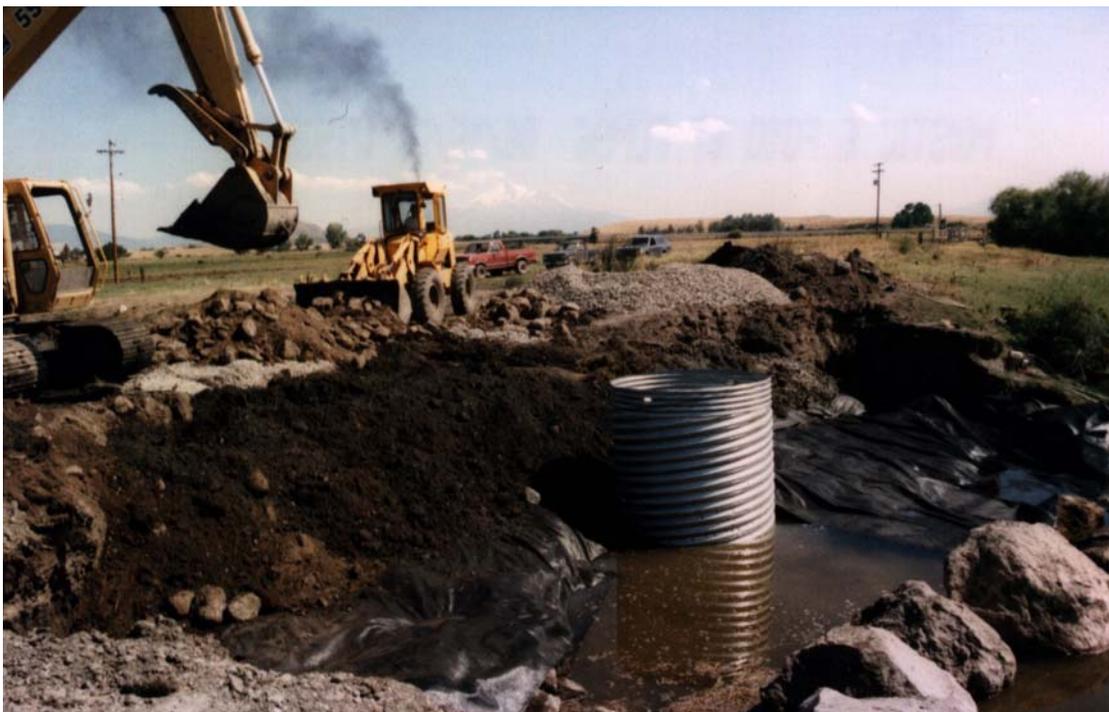
Twelve hours later the water level within the sump dropped so low that the pump sucked air and lost its prime. We restarted it, and the same thing happened within a few minutes. Apparently fines from the sand and gravel layer had migrated into the infiltration gallery and plugged it sufficiently to prevent its working.

Replacing soil over infiltration gallery. Geotextile fabric in place to minimize movement of fines downwards into gravel.

At that point we had essentially no money left from the original Task Force pump grant. We had a system that was not working, and the Fiocks would need to irrigate within a few days. We were trapped. We initiated discussions with the USFWS to search for a way to access additional funds on an emergency basis. With their help we were able to convert funds that had originally been slated for use in constructing livestock exclusion fencing to instead be used to re-excavate and re-install the infiltration gallery. We hoped that we would be able to do a better job the second time, and stay well within the original foot print, minimizing the further migration of sand and gravel from the edges.

We bought more excavator time, we bought more rocks, we re-opened the hole, removed nearly all the rocks, then re-installed everything. More geotextile fabric, more dirt over the top, then start the pump again. This time things worked fine. We rented a larger gasoline powered pump to do a simulated full capacity test (equal to both the 10 hp and 40 hp pumps running simultaneously)

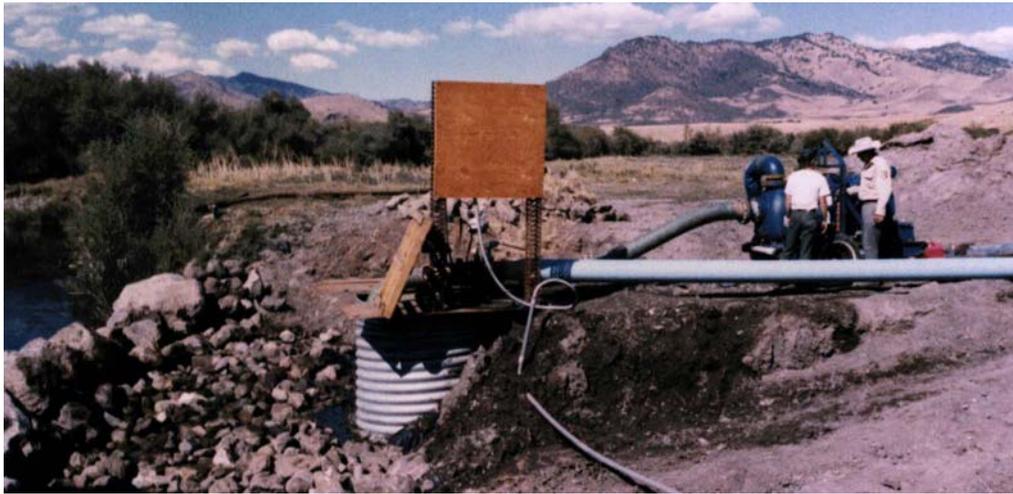
Drawdown test in progress, Sept., 1998

The water level dropped substantially, but we were able to keep pumping. We hoped that perhaps over time we would move fines through the gravel into the pump, then out onto the ground, slowly increasing inflow rates. That happens in wells, after all. The irrigation season of 1998 ended, and we staggered to a halt, glad to have gotten through, but without a feeling of certainty of how long the system would function.

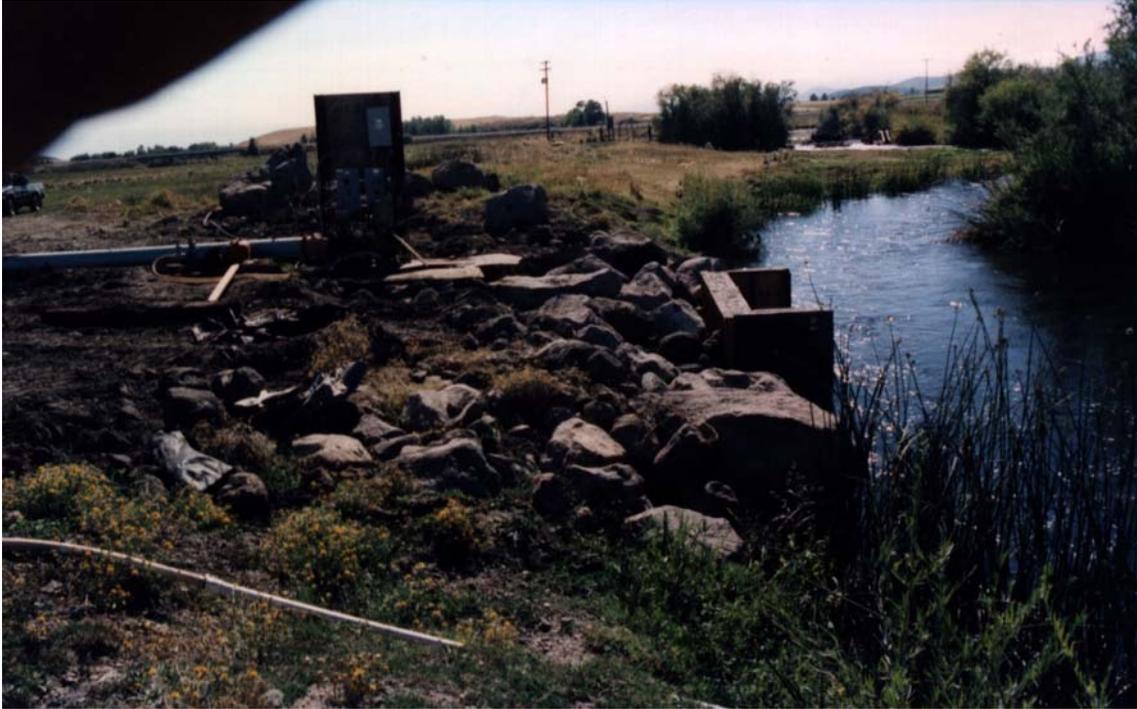
Concrete vault in place at end of irrigation season, 1999. Fish screen to be fabricated and installed over the winter.

Our plan at that point was to remove some of the infiltration gallery rock before the end of the summer of 1999, and in its place set a concrete vault designed to hold a flat plate fish screen and wiper assembly. Over the winter we would make the wiper and screen, and install it prior to the irrigation season of 2000. We would also proceed with the pipeline and pump re-location during the winter of 1999-2000.

During the last half of the summer of 1999, we designed, formed and pre-cast a concrete base for the vault. Once cured, we built forms on it to allow us to set it in place in the river, and pour its walls once it was in place. We included slots for inserting the screen frame, and a short length of 24” culvert in the back to connect it to the existing pump sump.

In late September, we went back to the river, new permits in hand, re-excavated the infiltration gallery, and installed the concrete base with attached forms. We then cut an opening in the side of the pump sump that we had installed the year before, inserted a culvert into the opening, and attached it to the stub of a culvert we had extending from the forms of the new screen vault. Next we replaced the fill material over that culvert and against the forms for the vault. Finally we poured the walls for the vault.

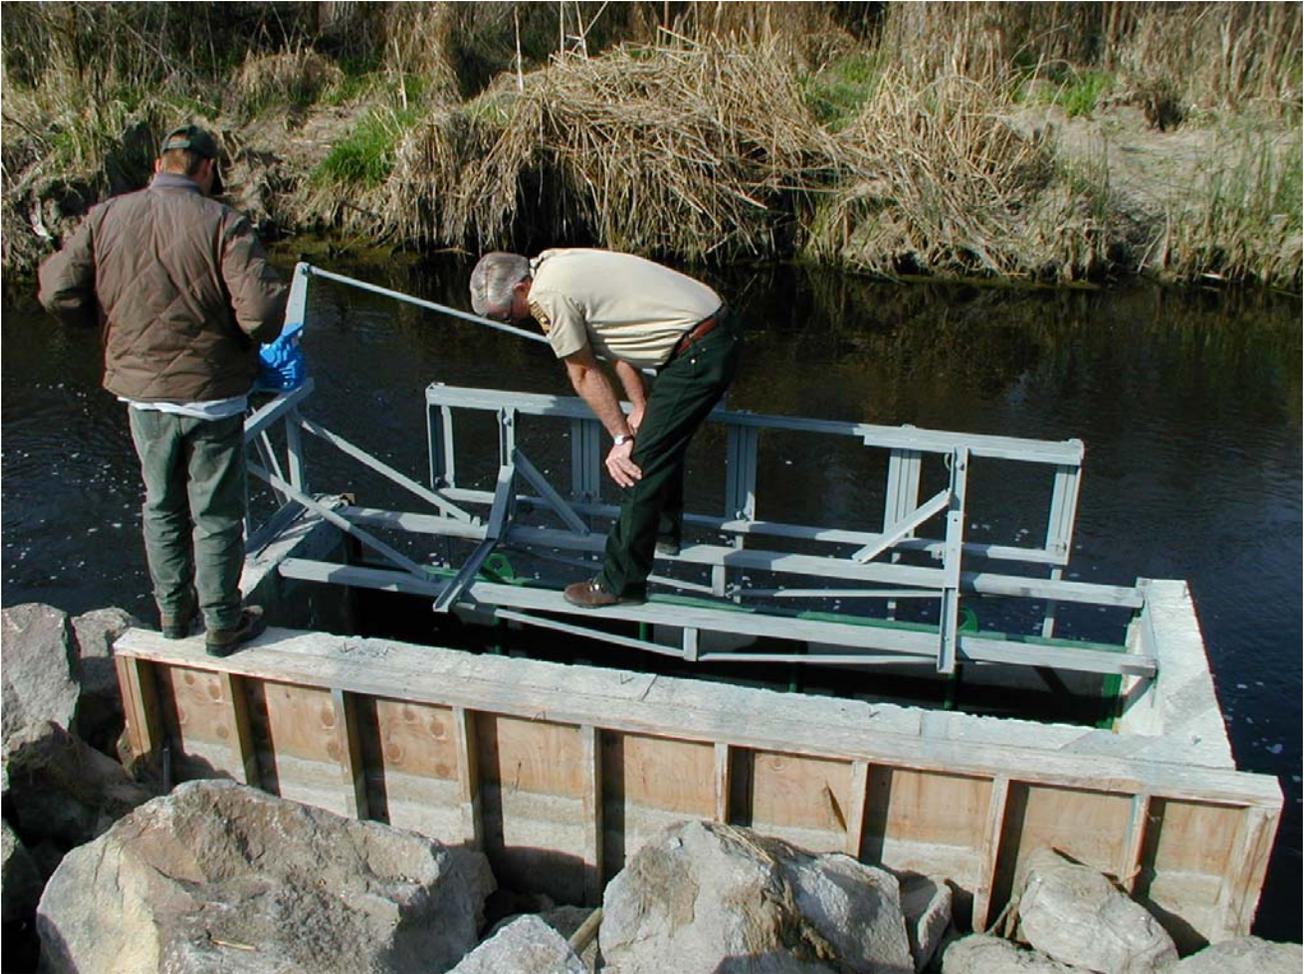
Mike Farmer and Ron Dotson (CDFG) inspect Fiock fish screen prior to installing covers and final backfilling.

Meanwhile, the fish screen and wiper mechanism had to be designed and fabricated. This work was done primarily on weekends by a DFG biologist and the CRMP coordinator. There was a lot to learn but by late March everything was ready to install.
