EXECUTIVE OFFICER'S SUMMARY REPORT
8:30 a.m., August 25, 2004
Crescent City Cultural Center
1001 Front Street
Crescent City, CA 95531

SUBJECT: Update on Elk River Flooding Analysis

**PRELIMINARY ASSESSMENT
OF FLOODING
IN LOWER ELK RIVER**

NORTH COAST REGIONAL WATER QUALITY CONTROL BOARD

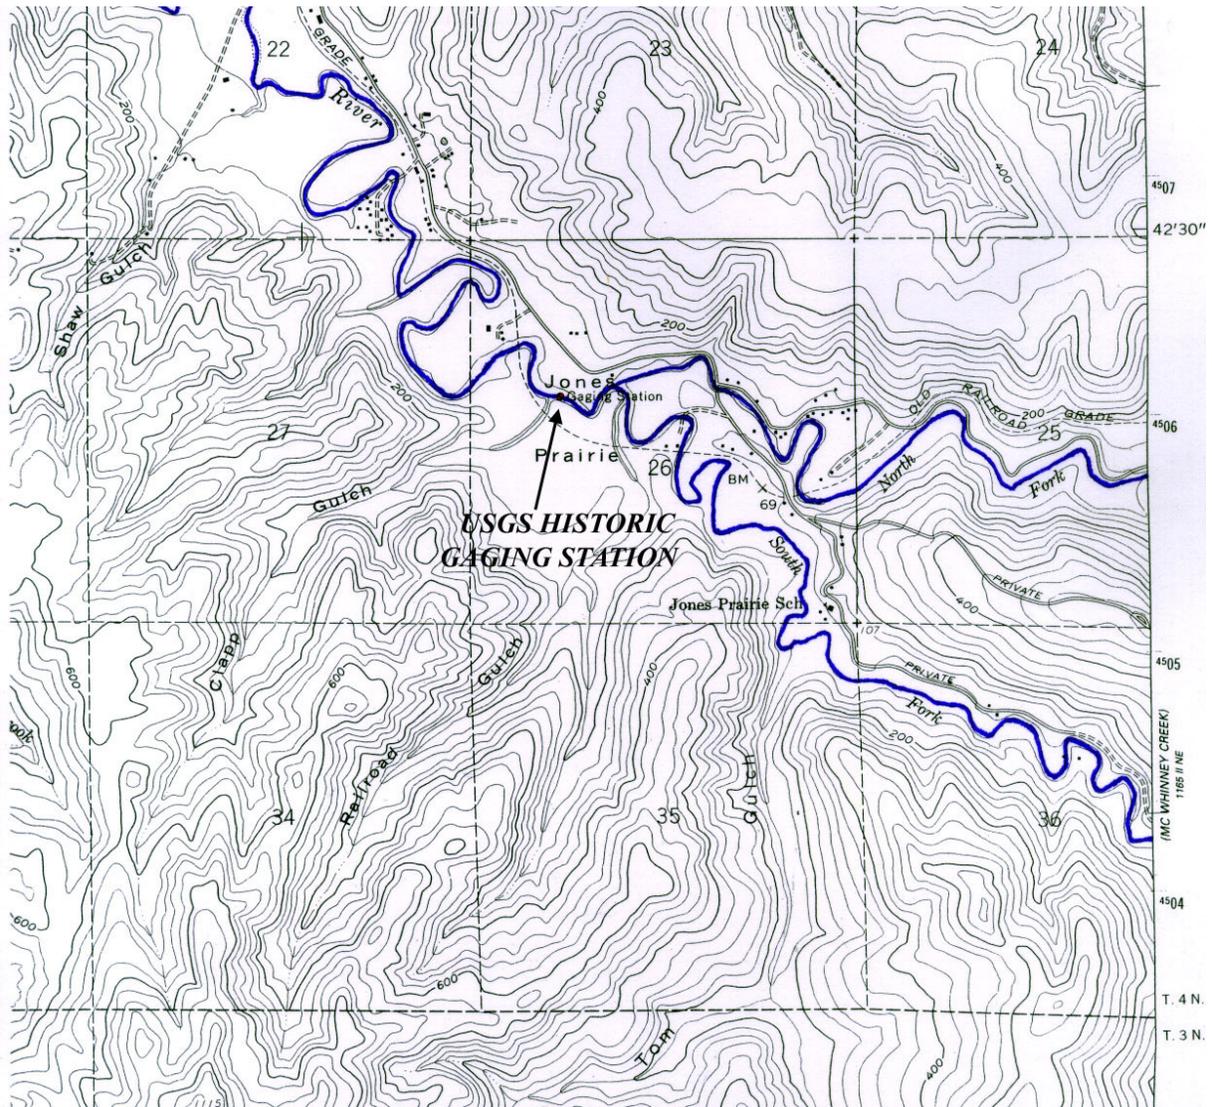
Figure 1. Location of Historic USGS Gage 11-479700, Elk River

USGS gage station 11-479700 is located just downstream of Elk River's main tributaries, North Fork and South Fork, where the river egresses from uplands onto the coastal plain (Figure 1). The drainage area above this gage station is 44.2 square miles. Railroad Gulch and Clapp Gulch, two small, steep tributaries are located upstream and downstream of the historic gage site, respectively.

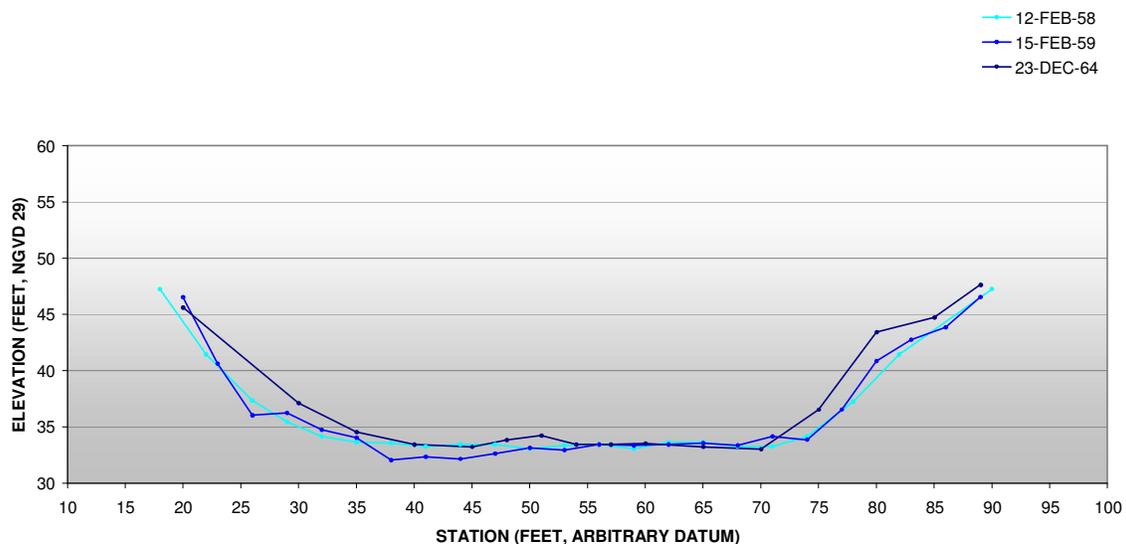
Figure 2. Cross Sectional Channel Topography at Historic USGS Gage Station 11-479700

Monthly cross sectional topography of the Elk River channel was reconstructed for a full record of water years (WY) 1958, 1959, 1960 and 1967, in addition to available individual records within WY 1961 through 1966. Since cross sectional area is derived from a measurement of water stage, high-water discharge records tend to be more topographically descriptive than low-water discharge records. Therefore, only three records that were measured during high-water events were used to determine the historic topography. Figure 2 illustrates cross sectional channel topography in WY 1958, 1959, and 1965.

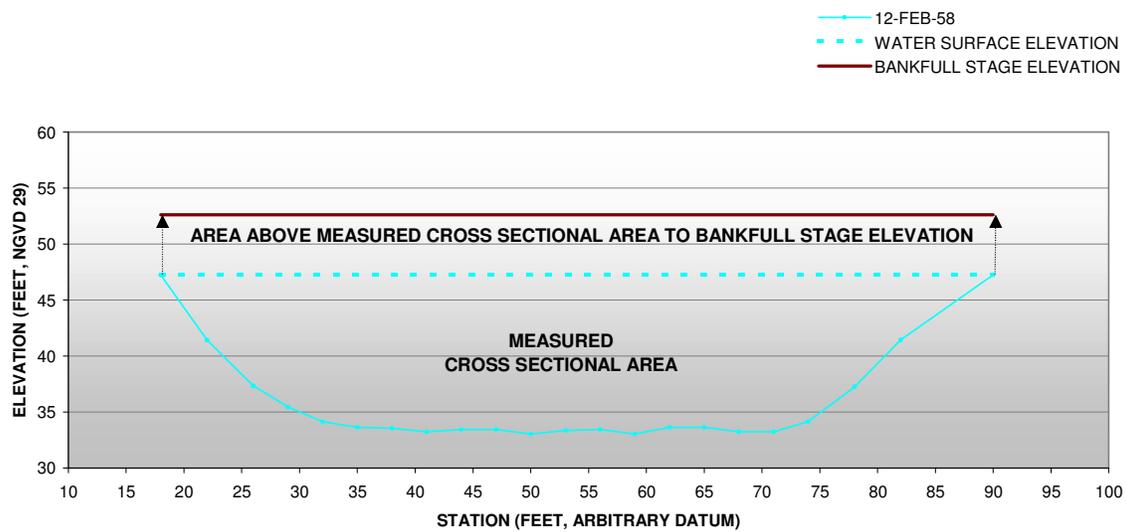
Figure 3. Method of Measuring the Channel Capacity

To compare the relative changes in channel cross sectional area, estimated cross section area related to bankfull stage and discharge is used. The cross sectional area at which the water fills the channel completely and the water surface is level with the flood plain will be referred to as the channel capacity.

USGS report a bankfull stage of 23 feet gage elevation (52.61 feet elevation, NGVD 29) and a bankfull discharge of 2250 cubic feet per second (cfs) (Young and Cruff 1967). USGS report bankfull discharge at gage station 11-479700 to be the discharge at which the water fills the channel completely and the water surface is level with the floodplain. All monthly measurements occur at a stage below bankfull, therefore the channel capacity is estimated to be the sum of the measured cross sectional area and the area above the measured area up to bankfull stage (Figure 3). This method may underestimate the channel capacity; however, this method is applied consistently. Table 2 summarizes estimated channel capacity as a function of cross sectional area in square feet (ft²) for WY 1958, 1959, and 1965.

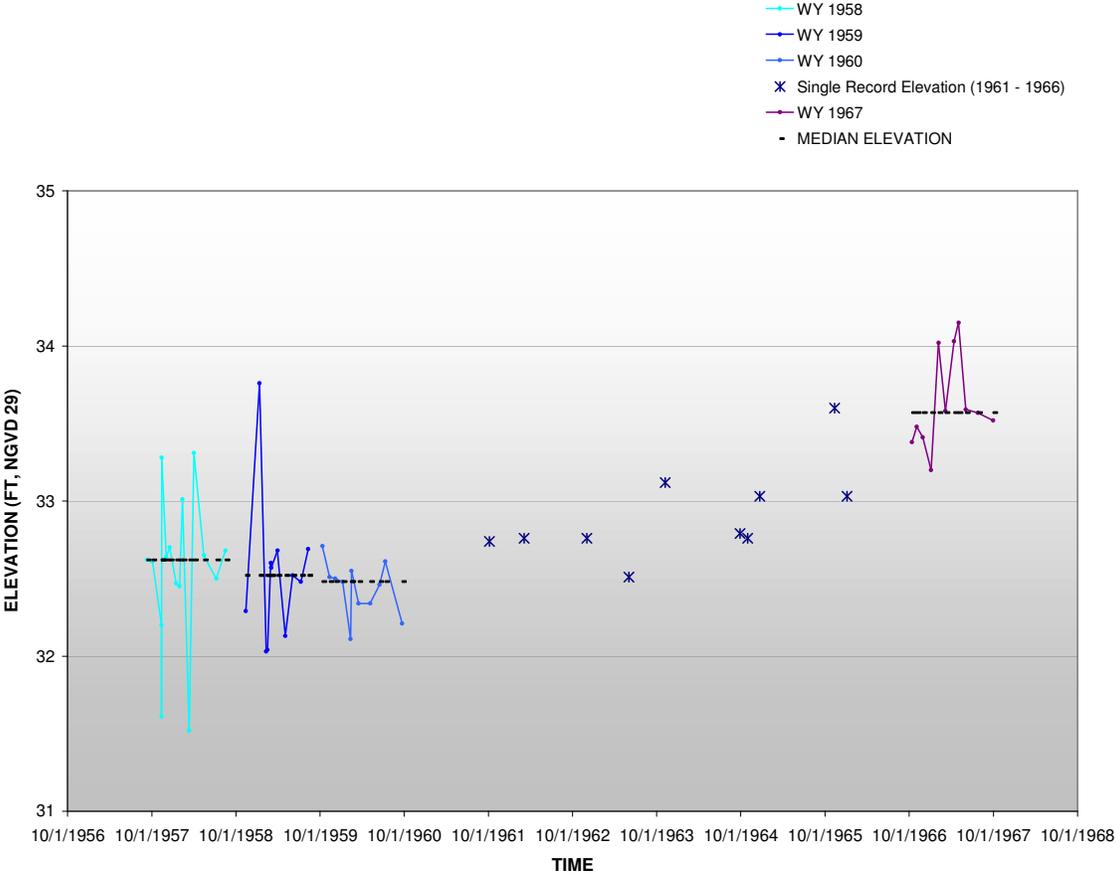
Figure 4. Channel Bed Elevation Fluctuation over Time

Channel bed elevation changes are analyzed by observing relative changes in channel thalweg elevations over time. Because the cross sectional data available from the USGS stream gage were not recorded at the exact location for each measurement, the annual median of the data is used. Reports of bed elevation fluctuations and changes in channel bed composition throughout the seasons suggest that the hydraulic system was episodic. USGS Water Supply Paper 1879-E tracks the variations in low-water streambed elevations at selected stream-gage stations in northern California (Hickey 1969). The reported difference between 1964 and 1965 low-water streambed elevation at USGS gage station 11-479700 is +0.7 feet. Figure 4 illustrates seasonal bed elevation fluctuations and relative elevations changes over time. The data suggest that the channel bed fluctuated over a stable median elevation prior to the December 22, 1964 flood event, after which the channel aggraded approximately 1 foot before WY 1967.

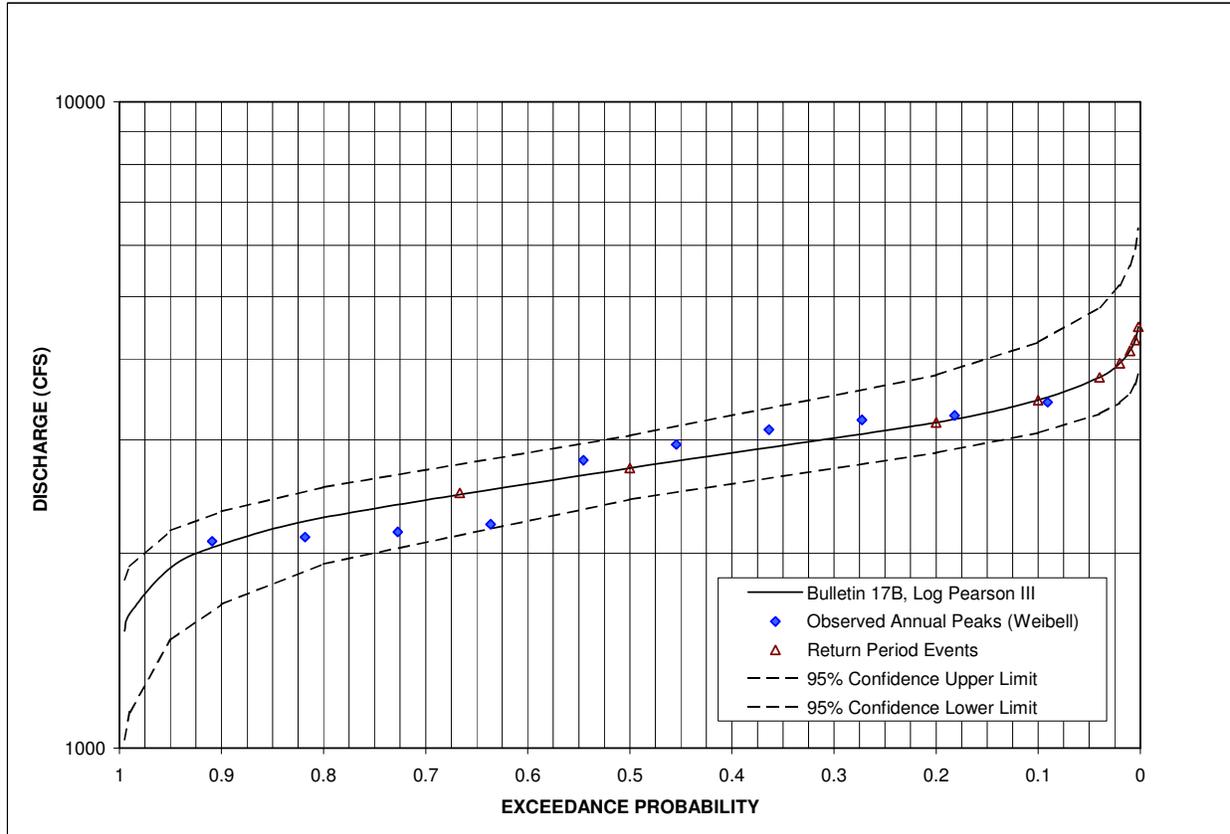
Figure 5. Estimated Probable Discharge Events from PEAKFQ Log-Pearson III Frequency Distribution

Instantaneous annual peak flows with recurrence intervals of 1.5-, 2-, 5-, 10-, 25-, 50-, 100-, 200- and 500-years are estimated with the use of PEAKFQ (v. 4.1). PEAKFQ is an algorithm that applies the Pearson Type III frequency distribution to fit the logarithms of instantaneous annual peak discharges following Bulletin 17B guidelines of the Interagency Advisory Committee on Water Data (1982). Results from applying the frequency distribution to Elk River historic data are presented in Figure 5 and Table 4. The Interagency Advisory Committee on Water Data suggests a generalized skew coefficient of -0.3 for the region of analysis, which was utilized in the analysis (1982).

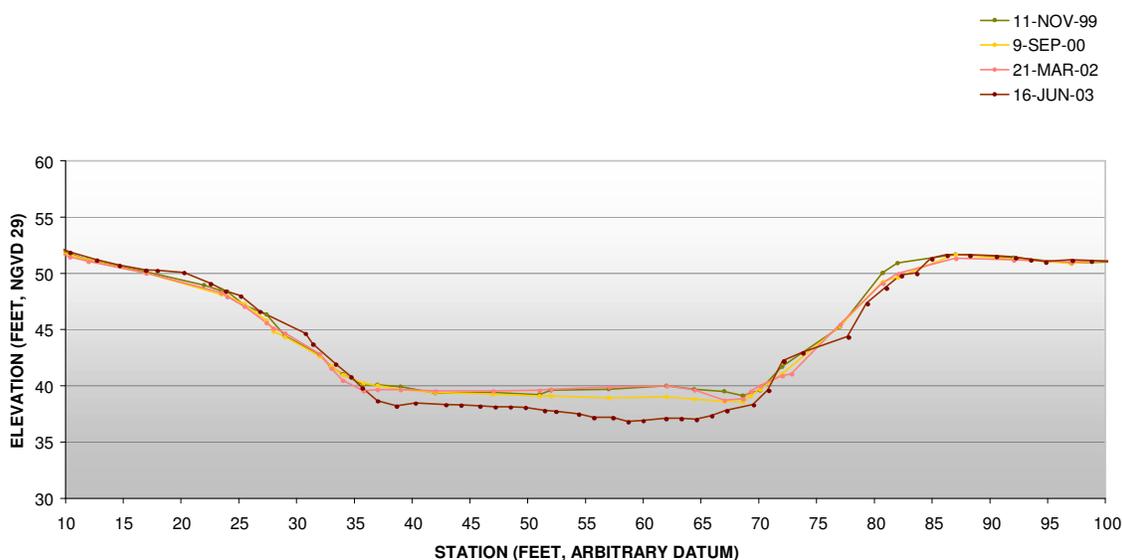
Figure 6. Annual Cross Sectional Channel Topography at Recently Maintained Gage, stations OERTCRB and 509

Bill Conroy and PALCO measured annual cross sectional topography at the mainstem station for WY 2000 – 2003 (Figure 6). Comparative changes in cross sectional area can be estimated similarly to the method used to estimate historic channel capacity.

Bankfull elevation is assumed to be the same as historic reports at 52.61 feet elevation, NGVD 29 and bankfull discharge is reported to be 882 cfs (Conroy 1998). Consistent with the method to estimate historic channel capacity, current channel capacity is estimated to be the sum of the measured cross sectional area and the area above the measured area up to bankfull stage (Figure 3). This method appears to slightly overestimate the channel capacity because the elevation of bankfull stage is approximately one foot above where discharge appears to overtop

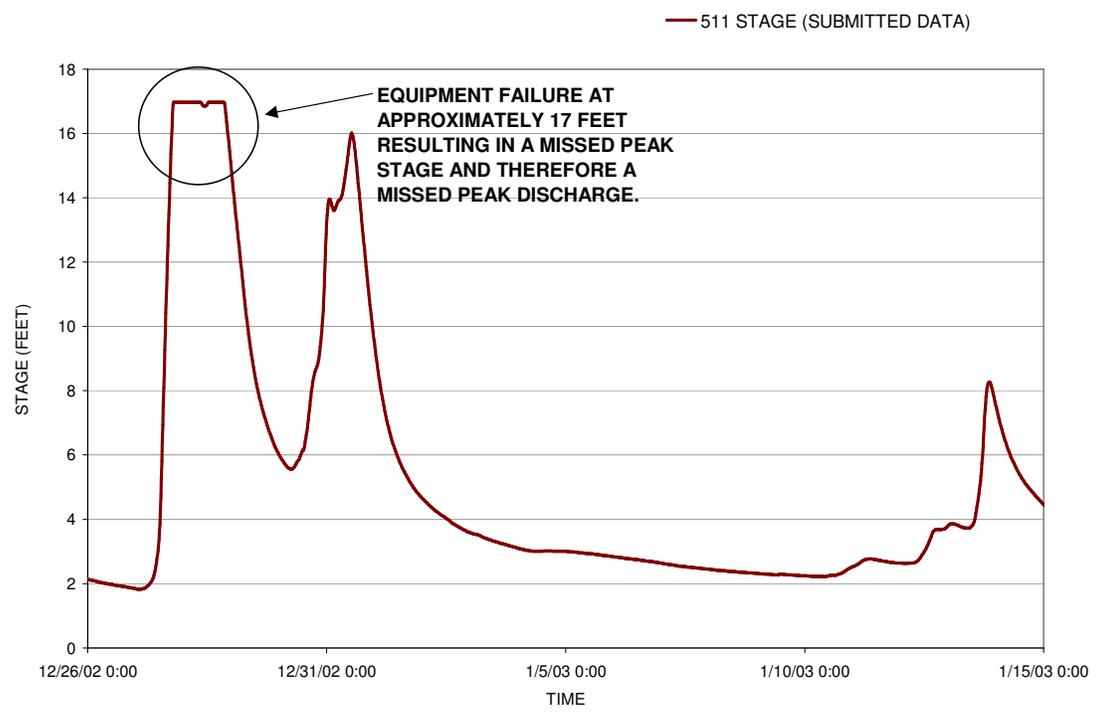
Figure 7. Hydrograph peaks at Station 511 illustrates why PALCO station 510 and 511 discharge data cannot be used for WY 2003

Based on rating curves and continuous stage records, hydrographs of continuous discharge were calculated for South Fork and North Fork Elk River. These hydrographs were only calculated for the SFM and KRW stations because the equipment at PALCO 510 and 511 stations appears to have failed to register stage above 20 feet and 17 feet, respectively, and therefore missed the storm peaks. Figure 7 graphically depicts the missing data. Figures 8 and 9 are the estimated hydrographs at monitoring stations SFM and KRW, respectively.

Equipment failures at PALCO station 509 resulted in a loss of stage data during the winter period of WY 2003. In response to this unfortunate event, PALCO submitted a synthesized hydrograph correlated to the 510 South Fork station. Upon review, Regional Water Board staff found inconsistencies in the synthesized hydrograph. Additionally, the discharge data calculated at the 510 station did not capture the peak discharges (in relation to peak stages), as discussed above.

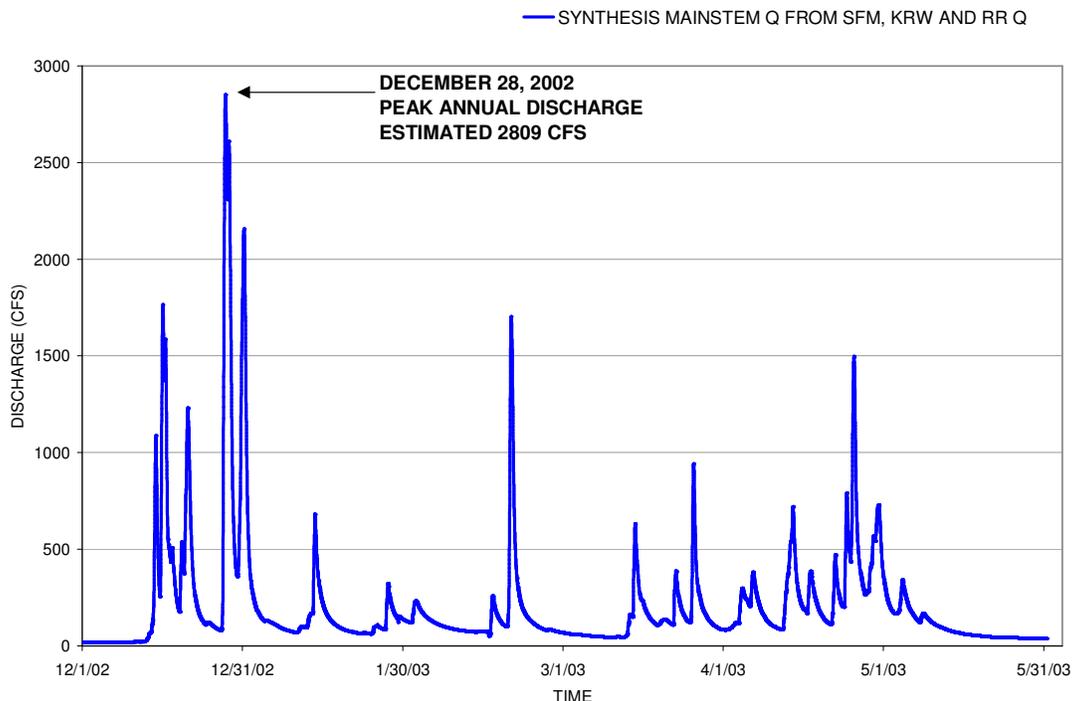
Figure 10. Synthesized Hydrograph for Mainstem downstream of Railroad Gulch

Figure 10 displays the synthesized hydrograph for mainstem Elk River downstream of Railroad Gulch. This hydrographic data will be used to determine stage at the PALCO 509 station and determine whether flood frequency has significantly changed over time.

In order to perform an analysis, Regional Water Board staff has synthesized a hydrograph from data recorded in both the North and South Forks at stations KRW and SFM, respectively. Upon detailed review and observation that the timing of the peak storm events is similar between the KRW and SFM records, these two hydrographs were summed.

The resulting hydrograph however was not sufficient to route back to the historic USGS gaging site or PALCO station 509 on the mainstem because a small tributary, Railroad Gulch, flows into the river just downstream of the confluence. In order to account for the relatively small influence of Railroad Gulch, a synthetic hydrograph was constructed for this tributary by correlating discrete discharge measurements at PALCO station 514 during recorded times with the SFM gage. The relationship was not robust, but it is considered a sufficient estimate for the purposes of this study. Railroad Gulch discharge does not contribute significantly to the synthesized hydrograph peak discharge, however the flows were added.

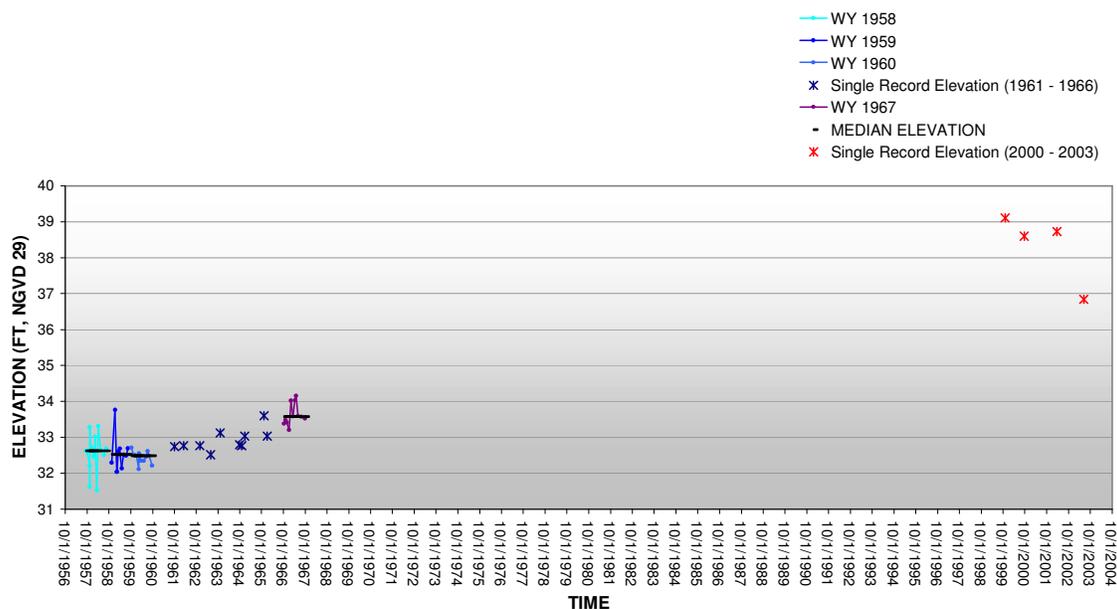
Figure 11. Channel Bed Elevation Changes over Time

The channel's bed aggraded approximately 5.5 feet between WY 1967 and 1999. A recent decrease in the channel bed elevation subsequent to the winter storms cannot yet indicate a trend. However, the channel bed was previously appearing unresponsive to winter discharges throughout the previous recent record and the decrease in elevation of 1.9 feet can be taken as a good sign of channel scour. Figure 11 illustrates these bed elevation changes through time.

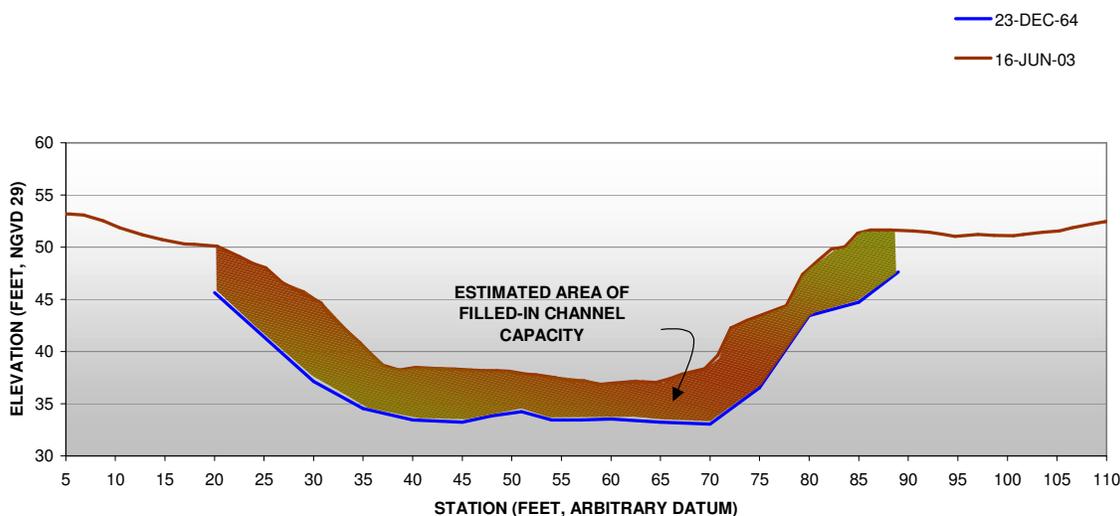
Figure 12. Illustration of Diminished Channel Capacity, Compared between WY 1965 and 2003

A significant change in channel capacity as a function of cross sectional area is observed in mainstem Elk River (Figure 12). Assuming again that the elevation of bankfull discharge has not changed in relation to the two systematic periods of record, the current 2003 channel capacity is 400 square feet less than the 1965 historic channel capacity. Another perspective is that channel capacity as a function of cross-sectional area has decreased by at least 35% or that the channel currently has 65% of the historic cross sectional area available to convey instream discharge downstream:
