Idaho Panhandle National Forests
FOREST PLAN
MONITORING AND EVALUATION REPORT
2001

2001 Central Zone Watershed Monitoring Report
Idaho Panhandle National Forest
Coeur d'Alene River Ranger District
November 15, 2001
Hunter Techau

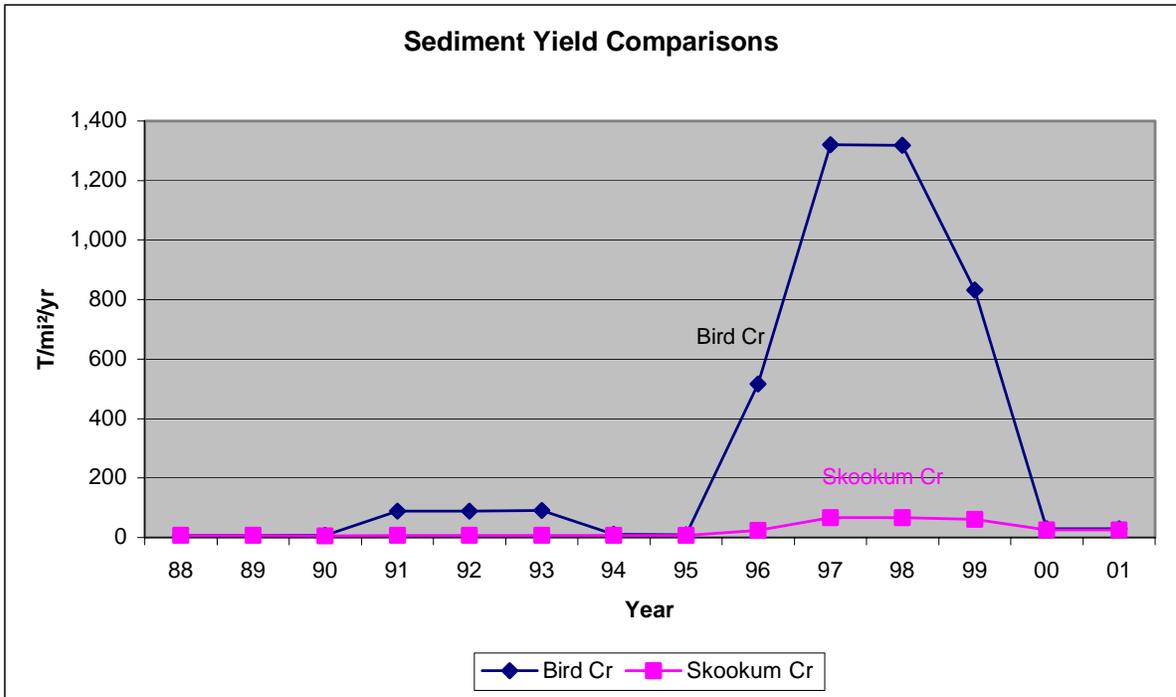
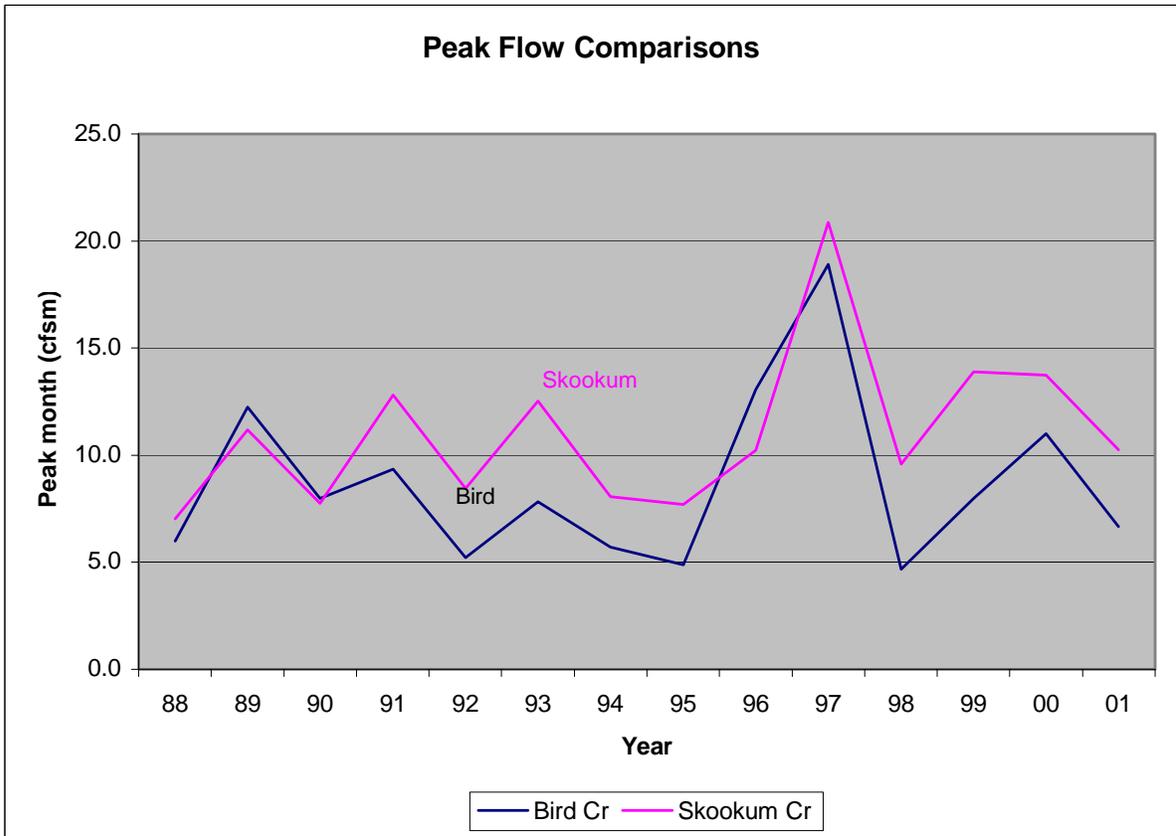
Figure 5. Sediment Yield and Peak Flow Comparisons

Comparing the measured streamflow and sediment loading response in Bird Creek (an intensively developed watershed) and Skookum Creek (an essentially undeveloped watershed immediately to the west of Bird Creek); it is apparent that:

- o Skookum Creek produces greater peaking flows per unit area than does Bird Creek, even during extreme events; and
- o Bird Creek moves far more sediment under similar climatic regimes, especially during and following years exhibiting infrequent (large flood periods) events such as 1996 and 1997.

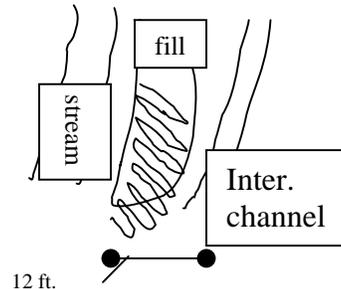
2nd crossing -- Gabion in seep next to crossing is functioning well. No signs of failure or rerouting.

- Stream crossing has 10 feet of fill next to stream. A large water bar diverts surface flow from cutting the fill into the stream.

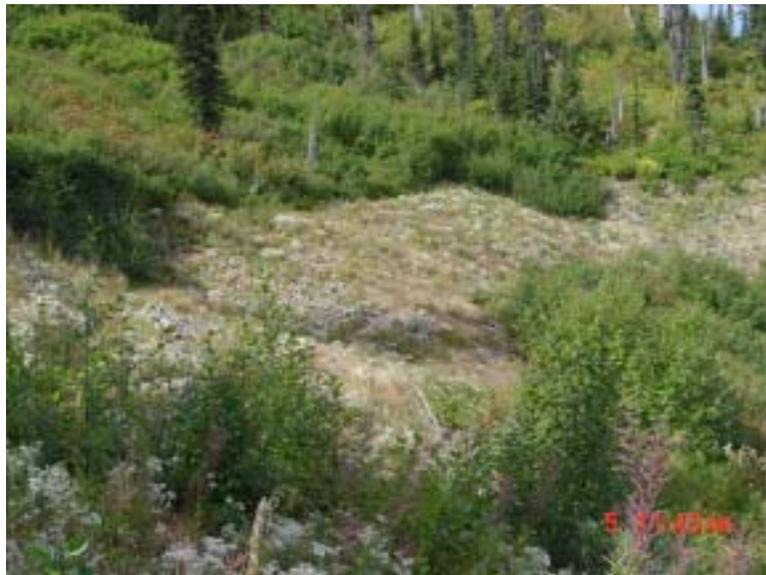
Pic. 1 – 1326 road

Pic. 1 is a crossing on a very steep slope. The approx. fill depth was 70 ft. The oblit is stabilized and is established with Yarrow, alder, fireweed, and grasses.

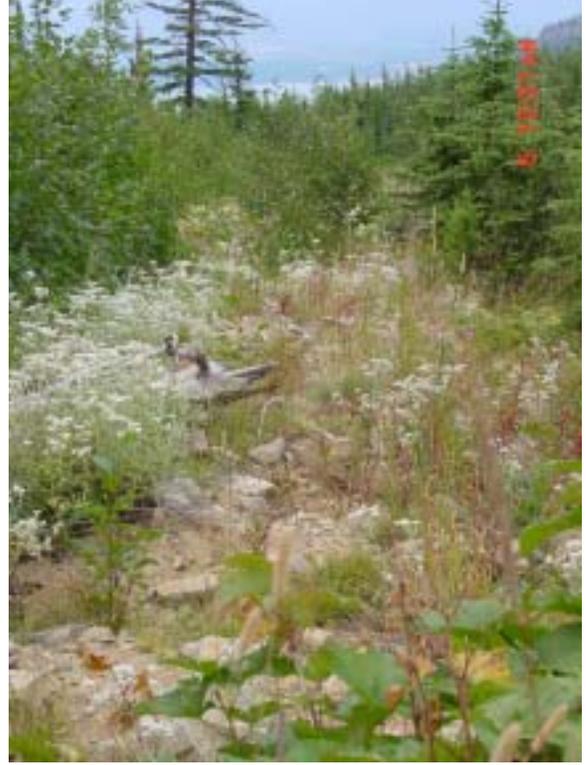
Pic. 3 – Bucket rip on 1082B road.

Pic. 3 and Pic. 4 show bucket rips on 1082B road. Pic. 3 illustrates the flora that dominate the site (Yarrow, alder, fireweed, grasses, and huckleberry). Pic. 4 illustrates the ripping pattern of a bucket rip. The bucket rip leaves a water bar appearance and tills the substrate.

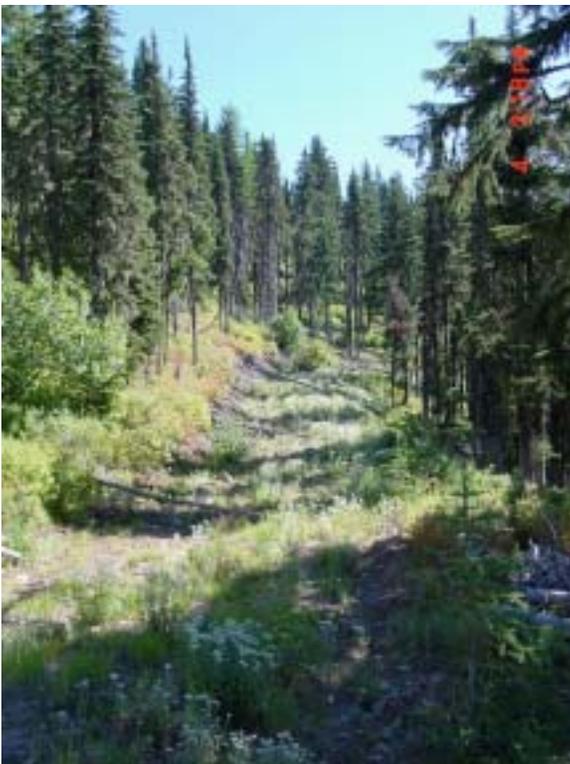
Pic. 6 – 1082D Cochran's Draw X-ing cut bank failure

Pic. 6 shows a small slide next to Cochran's Draw. The slide occurred on the cut bank side of the road it is 25ft. x 50ft. and stops on the oblit. The water temp. at Cochran's Draw was 7°C.

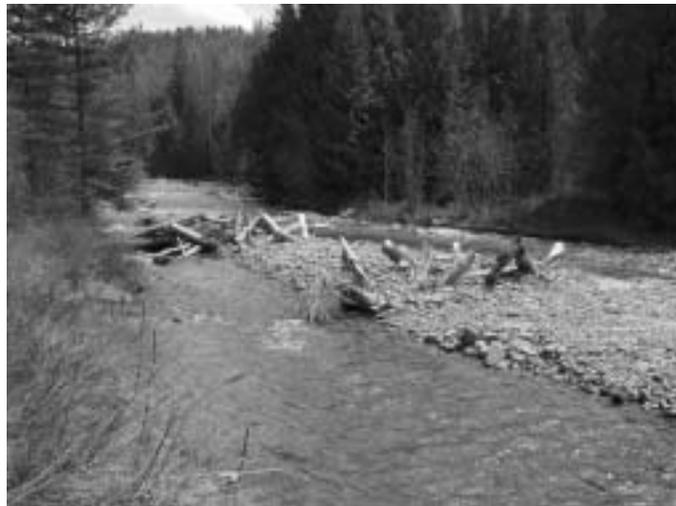
Grouse Creek Photo Point #2

This monitoring project was initiated on Grouse Creek in 1997 prior to a large stream enhancement project. Seven photo points were established along a one mile section of lower Grouse Creek. Several photos were taken at each site to capture upstream, cross-channel, and downstream views. Setting up each site entailed finding a good observation point, taking compass bearings so that each photo can be accurately reproduced, recording photos, and installing a permanent monument. This summer a new set of photo points was added to the monitoring project bringing the total of photo points along Grouse Creek to eleven. These four new sites are intended to document existing conditions in the Grouse Creek channel in section 20, below the past project sites. For summer 2002 we are proposing a stream enhancement project and these new photos will be useful in documenting changes in the channel. The existing photos have proven a useful reference tool for determining the extent of channel changes and for relating the effectiveness of our enhancement projects.

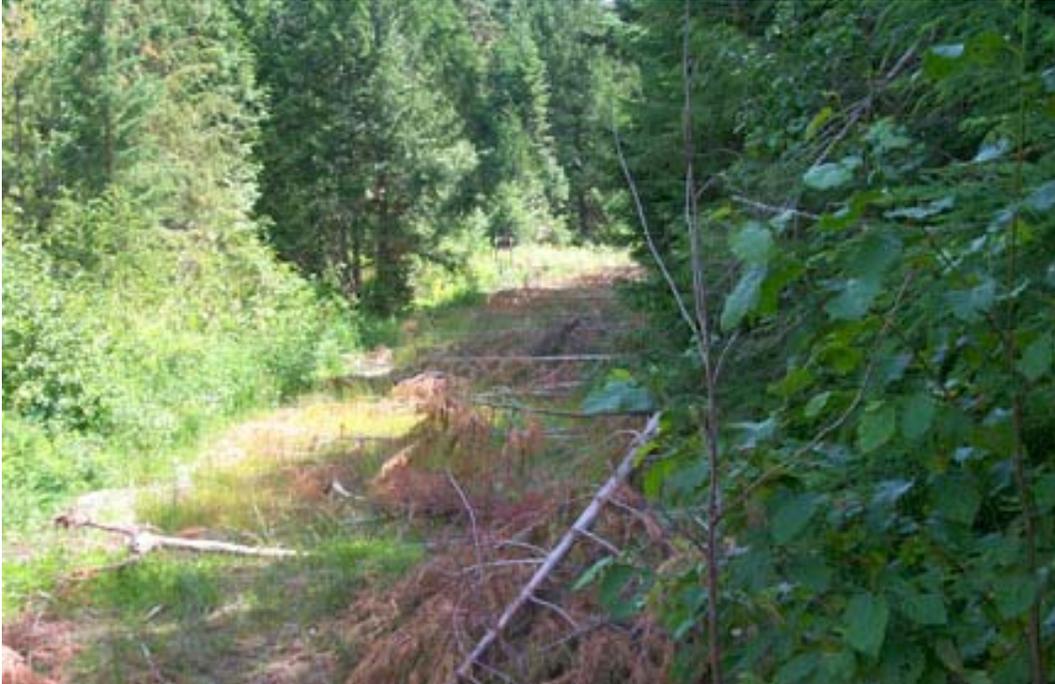
- 1) The seed that was spread on the snow did not take hold like the seed that was spread in August when the soil was originally exposed.
- 2) The sites where the culverts were removed looked well overall, there was no additional down cutting.
- 3) The “created” stream channel connecting the wetland to the main channel looked very stable. It was beginning to revegetate and there was no major down cutting.
- 4) The 50 cedars that were planted in the spring of 2001 had marginal success. This is likely due to the fact that the residual road fill was not ripped and therefore the compacted material was not conducive to the trees survival.
- 5) The hydroseeding and use of slash filter windrows on the newly constructed cut and fill slopes of Road 312 very effectively reduced erosion.

Photo showing obliterated portion of Road 312. This portion was hand-seeded over snow.

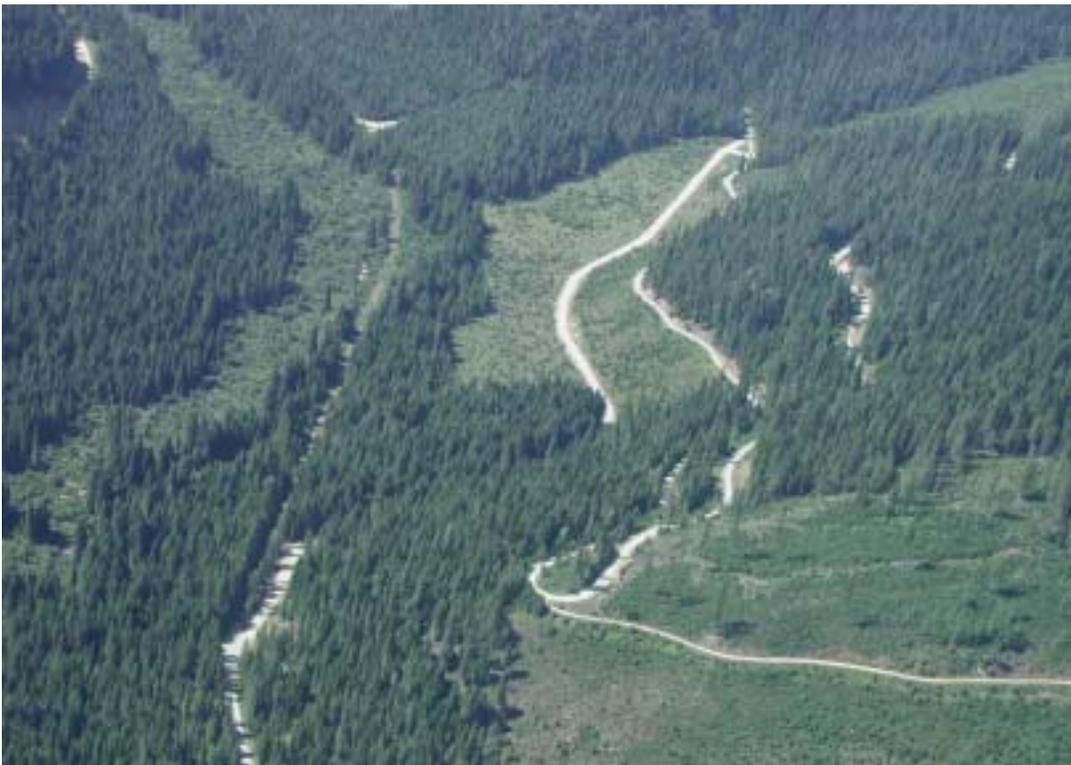
Photo showing reroute and obliteration of Road 312. Oblit. is linear feature on left. The new construction is the bright white road extending from the bottom left to the center.

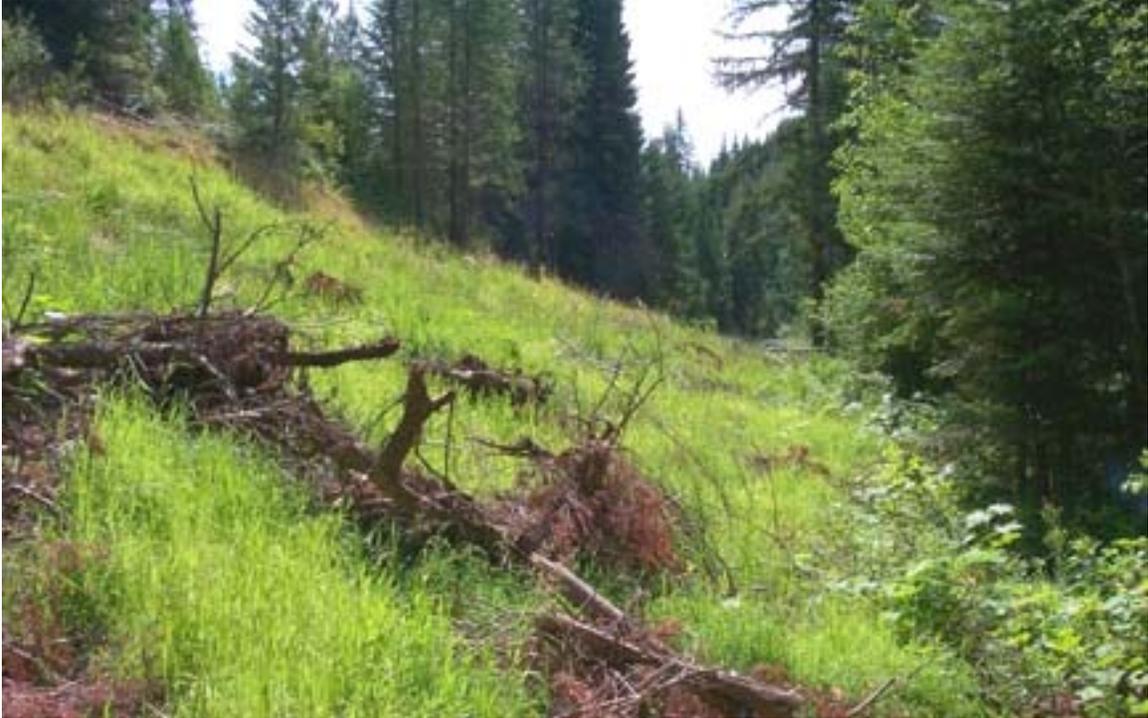
When the site was resurveyed in July of 2001, the grass growth was thick and ranged from 1.5 to 3 feet high. The cedars were also still alive. The site did not show any active erosion. This was attributed to the successful use of grass seed, mulch and slash along the disturbed sites in the riparian zone and along the new construction.

Recontoured portion of “old Road 416” adjacent to Quartz Creek. Note the use of slash and the successful revegetation of the slope.

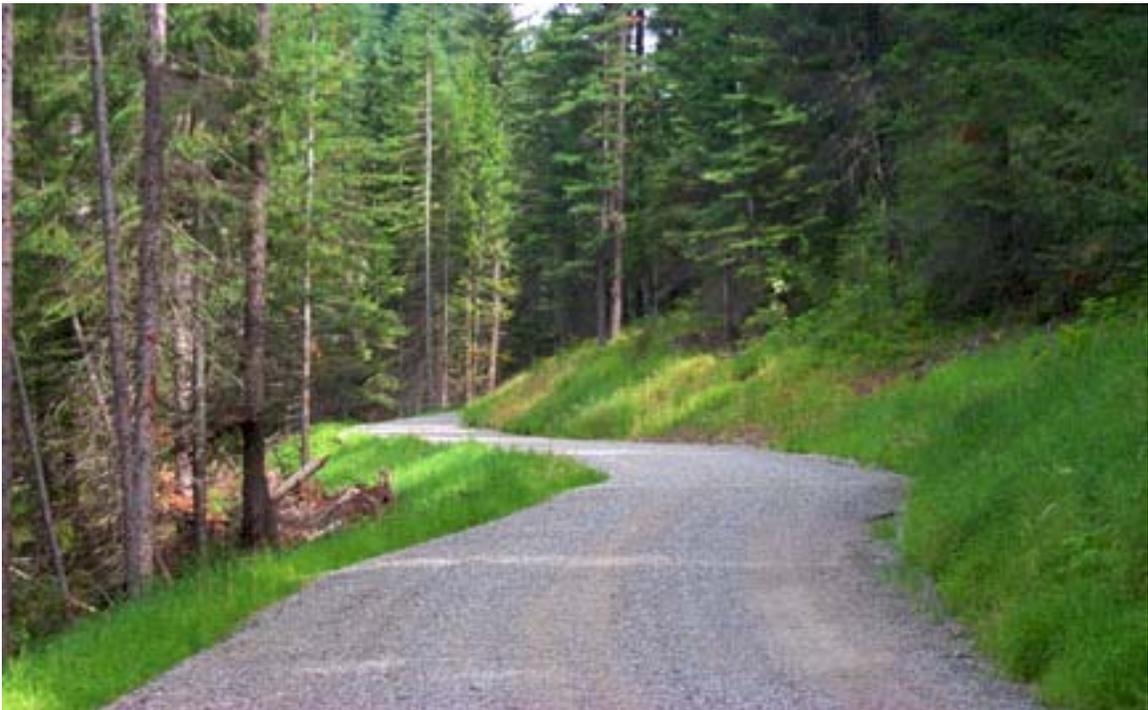
New construction of relocated Road 416. Note the stable lushly vegetated cut and fill slopes and the use of slash filter windrows.

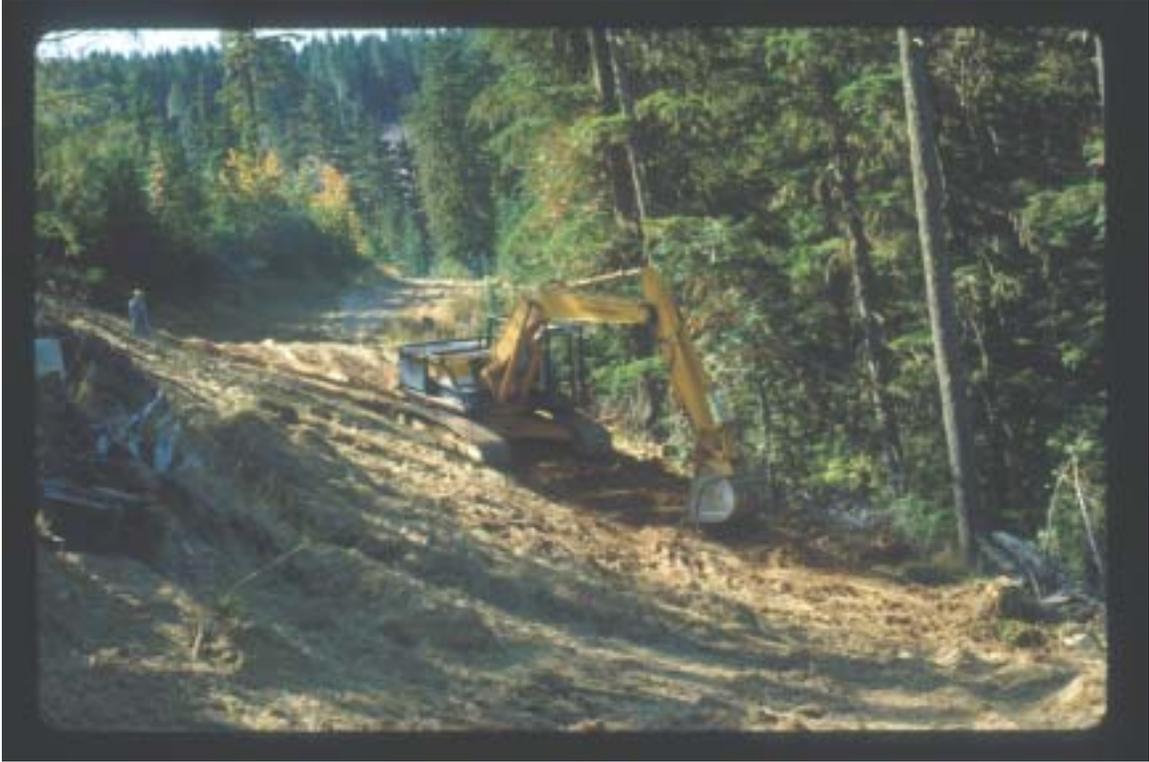
Photo taken in 1991 on Road 1382D in the South Fork of Gold drainage

In 2001, the District hydrologist reviewed the site and found that the stabilization was very effective in several ways. The recontoured slopes were well grassed, the planted conifers trees were up to 5 feet tall and the planted willows were well established. The two attached photos show the original ground work and the same view eleven years later. For orientation, note the large hemlock in the background and the triangular openings in the background when comparing the two photos from 1991 and 2001. Also note that the man standing on the slope on the left side of the photo is the same slope that is grassed in on the 2001 photo.

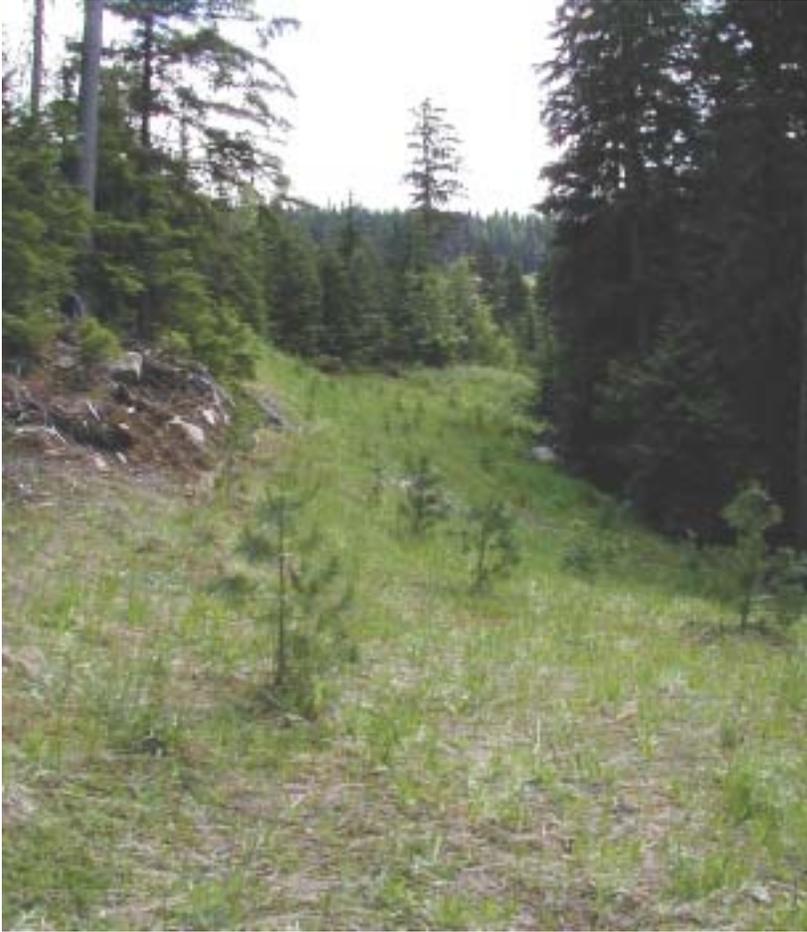
Photo taken in 2001 on the 1382 Road in the South Fork of Gold drainage.

Lessons Learned: Years after the project, it appears that there is little difference in stabilization between those streams that were stabilized with mats and those that were not. Also, it is important to use grass, mulch and seed over the entire length of the disturbed soils. This coverage prevents erosion and inhibits the spread of noxious weeds. It was useful to plant conifers on the slope because the grass seeding would have delayed natural regeneration of conifers because of competition. Finally, a blend of partial and full recontouring worked very well on roads constructed on glacial tills because it allows for the dispersion of water across the slope.

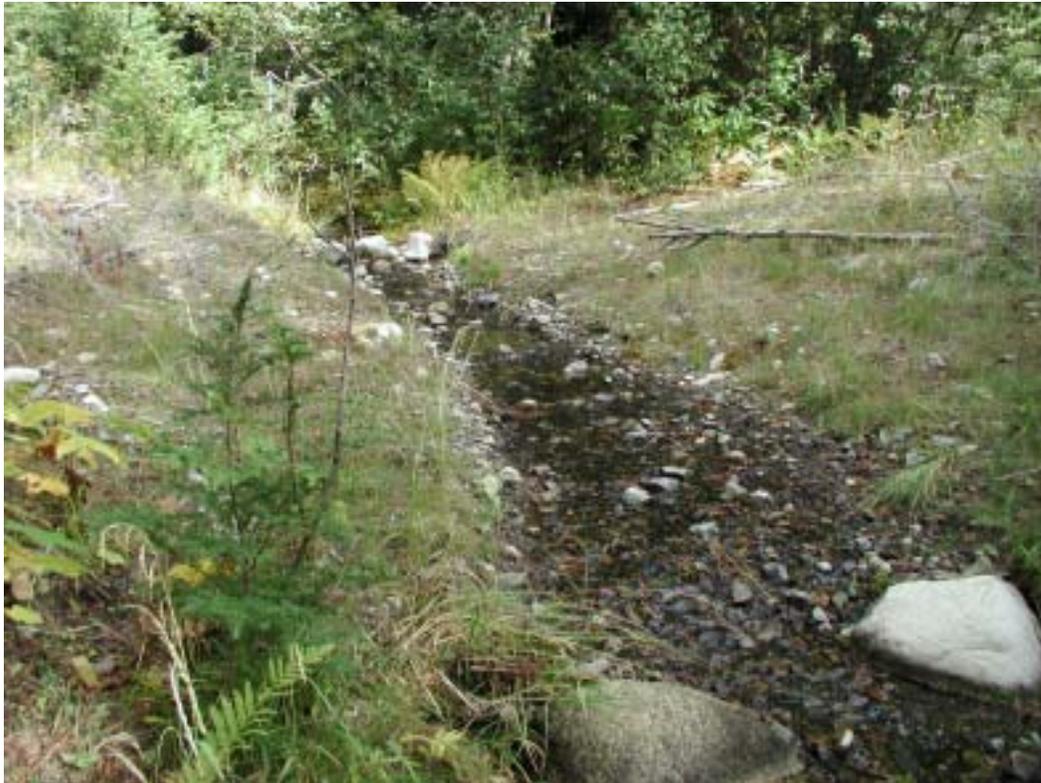
In September of 1998, portions of USFS Roads 311 and 1104 were obliterated using 10% dollars. Since the original obliteration work was completed, the road has been surveyed in 1999 and again in 2001. The review in 1999 noted a limited amount of downcutting but no significant concerns. The road review in 2001 found similar results. The photo documentation of the 2001 review shows that grasses are well established near the crossings and that the streams are stable. Grass coverage is relatively sparse between the crossings. The reviewer also noted that alder was becoming reestablished in the road prism. This road was not planted after it was obliterated.

Reclaimed stream crossing on “old” Road 311.

Lessons Learned: Some of the crossings should have been pulled more deeply and more slash should have been used as mulch. Heavier application of grass, fertilizer and mulch should have occurred between the stream crossings.

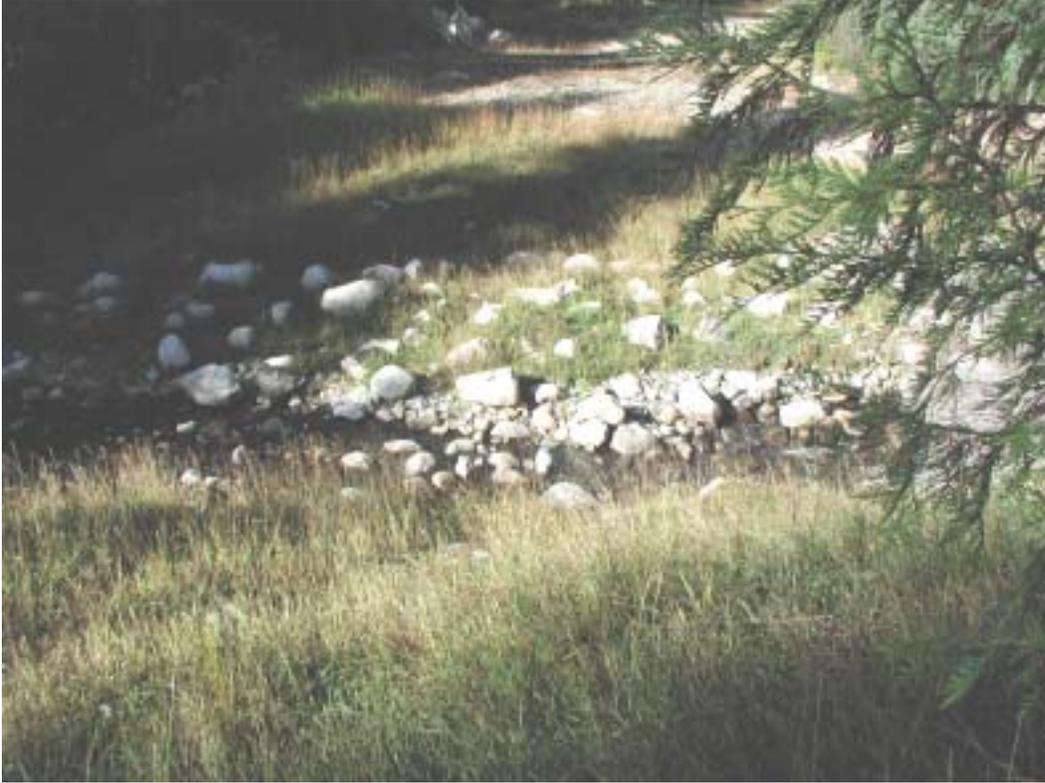
Cache Creek crossing on the “old” 311 road. On the earlier reviews in 1993, this crossing was considered a fish block. This restoration effort removed the fish block.

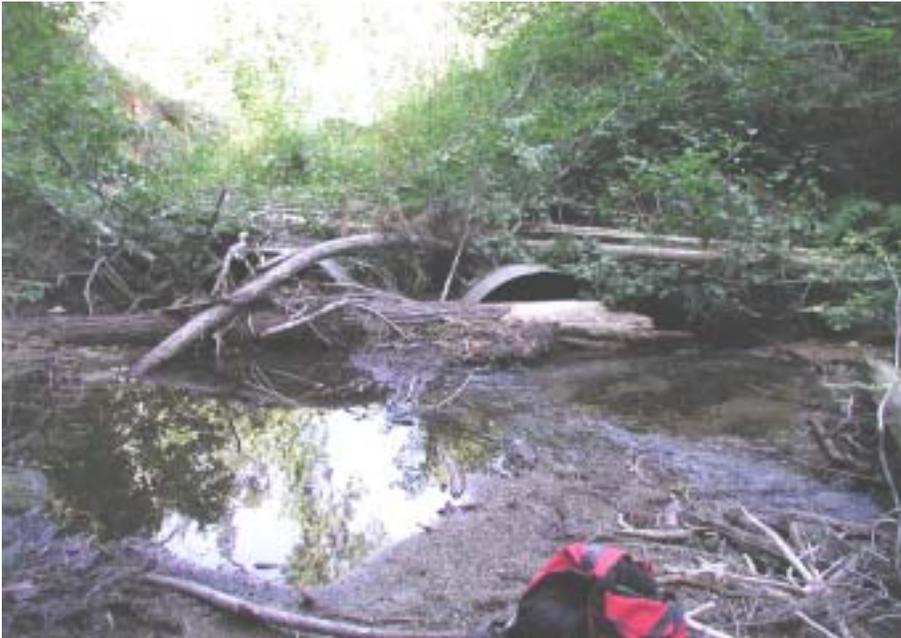
The large failure that was originally reported to the District Hydrologist was caused by a debris jam blocking the inlet of a pipe carrying Spread Creek. The failure caused a loss of the road prism that measured 74 feet long, 12 feet deep and 38 feet across. This failure on the road is attributed to a longterm lack of regular road maintenance of this system road. The majority of the road is very stable and is not prone to failures.

Inlet of culvert on Spread Creek under what was Road 1013.

Lessons Learned: We need to improve our road maintenance behind barriers.

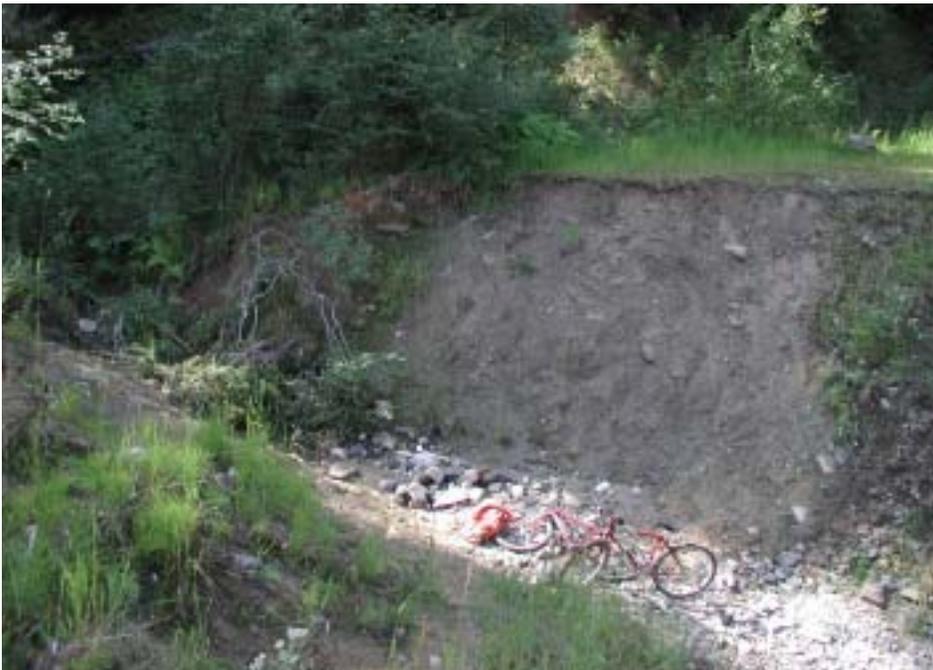
Fill Failure on Spread Creek at the Road 1013 Crossing. Note: the double culverts are still crushed and underneath the failure.
