Geomorphic Processes and Aquatic Habitat in the Redwood Creek Basin, Northwestern California

U.S. GEOLOGICAL SURVEY PROFESSIONAL PAPER 1454

Mass Movement in the Redwood Creek Basin, Northwestern California

U.S. GEOLOGICAL SURVEY PROFESSIONAL PAPER 1454-G

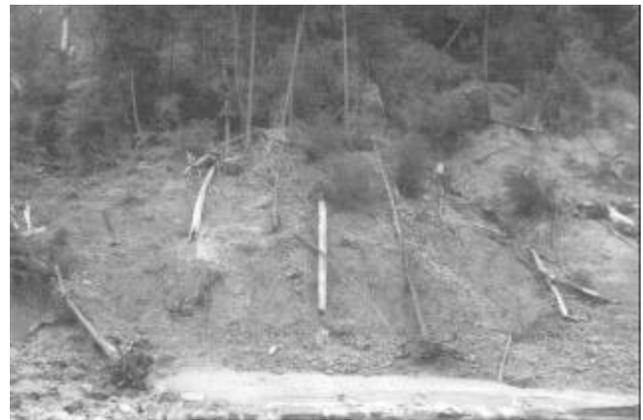
FIGURE 2.— Streamside debris slide, about 20 m in height, along the main channel of Redwood Creek about 6 km upstream from State Highway 299.

Debris slides produce well-defined, nearly planar failure surfaces as a result of discrete, episodic failures. Movement is dominantly translational and generally involves the upper 2 to 4 m of colluvium and fractured bedrock (Marron, 1982) (fig. 2). Debris slides in the Redwood Creek basin are concentrated on streamside hillslopes (Colman, 1973; Nolan and others, 1976) and adjacent to roads and log-loading decks. Examination of time-sequential aerial photographs indicates that most slides are initiated during major winter storms, sometimes in conjunction with human disturbance. Although partial stabilization of streamside debris slides may occur within several years, activity on portions of many failures persists for decades.

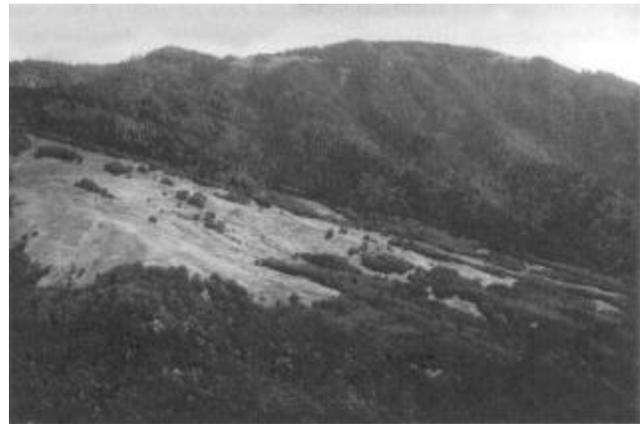
FIGURE 5.—Contrast between earthflow terrain (foreground) and steeper debris-avalanche terrain (background). Area shown is in the Lacks Creek basin. Local relief is about 300 m.

The terrain formed by shallow debris avalanches contrasts sharply with earthflow terrain in the basin (fig. 5). Debris avalanches are restricted to steep slopes underlain by massive, resistant sandstone units within the unmetamorphosed Franciscan assemblage (Harden and others, 1981). The upper portions of Lost Man and Little Lost Man Creeks and the northwest-trending part of the Lacks Creek basin are two prominent examples of debris-avalanche terrain in the basin.

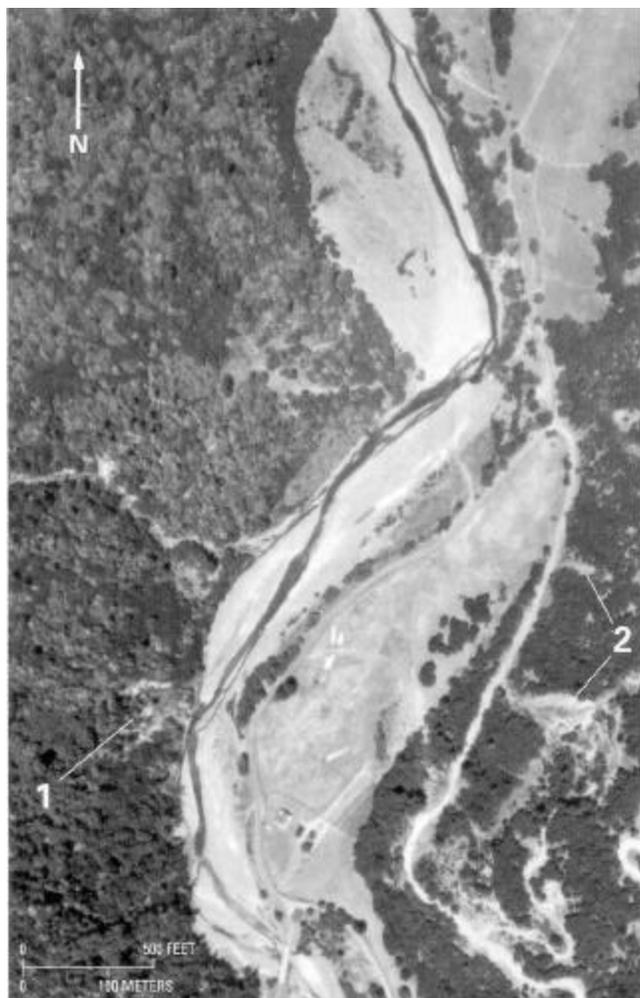
FIGURE 6.—Protective influence of flood plains on streamside hillslopes. Streamside landslides are numerous where Redwood Creek abuts hillslopes directly (1). On opposite bank, landslides (2) are separated from the active channel by a low flood plain. The photograph depicts the main channel of Redwood Creek immediately below the mouth of Minor Creek.

Flood plains play an important role in controlling streamside landslides in the basin (Janda and others, 1975). The wide alluvial flats in lower Redwood Creek and in Redwood Valley (Harden and others, 1981) (fig. 6) protect the toes of streamside hillslopes from undercutting. Slopes along these reaches of Redwood Creek are therefore less susceptible to the destabilizing effects of flood-induced aggradation (chap. N, this volume).
