**STREAM INVENTORY REPORT**  
**LITTLE NORTH FORK GUALALA RIVER**

*Prepared for:*  
**GUALALA REDWOODS**  
P.O. Box 197  
Gualala, CA 95445

*Prepared by:*  
Dan Gale  
**ENTRIX, Inc.**  
590 Ygnacio Valley Road, Suite 200  
Walnut Creek, CA 94596

**March 28, 1995**

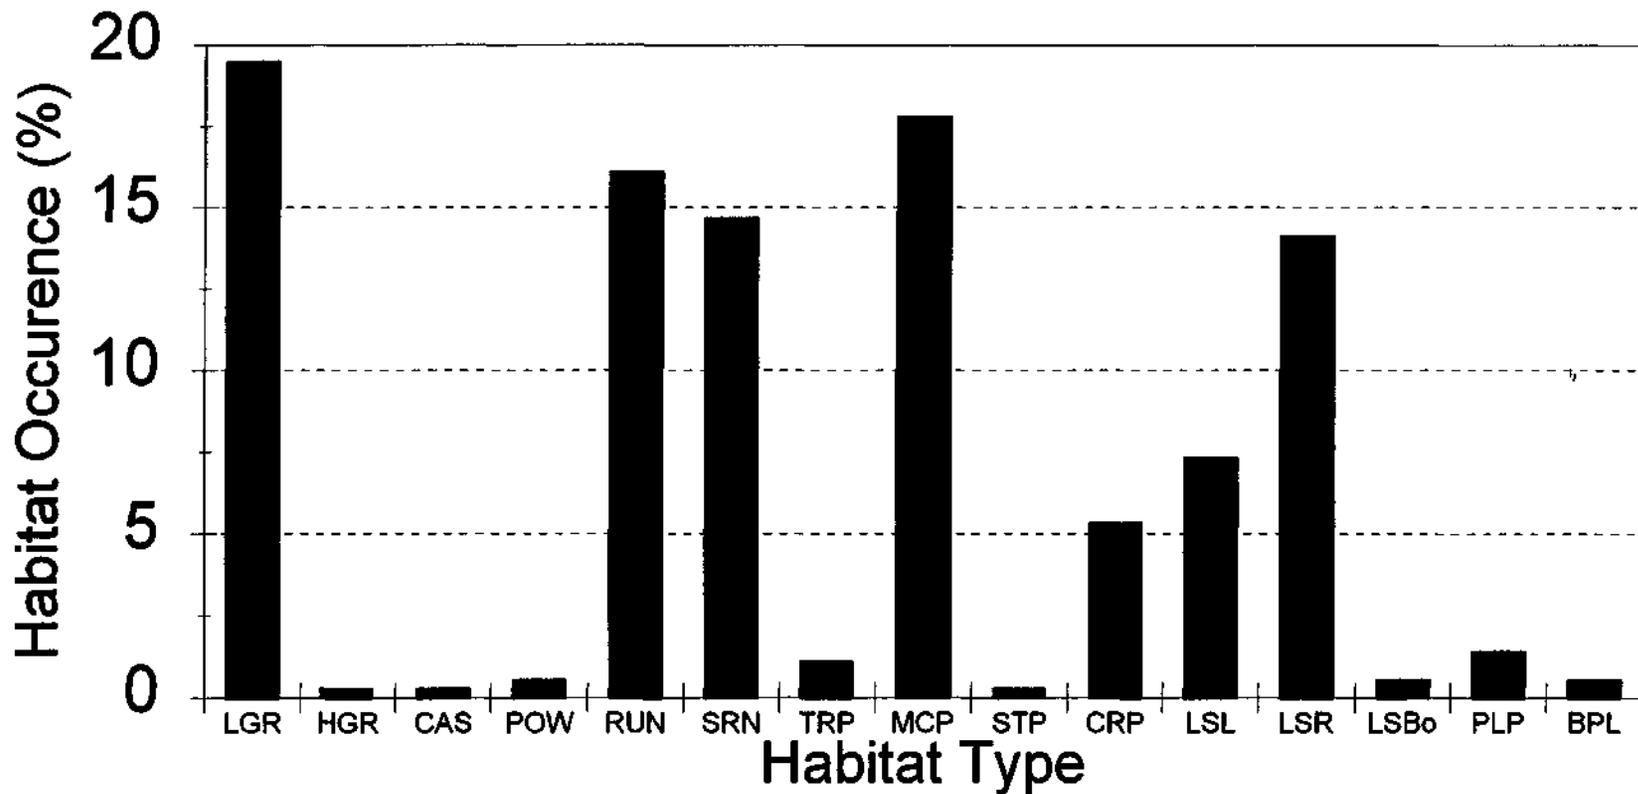
**Figure 4. Little North Fork Gualala River  
Pool Types by Percent Occurrence**

A total of 172 pools were identified (Table 3). scour pools were most often encountered at 59%, and comprised 49% of the total length of pools (Figure 4). Mid-channel pools accounted for 40% of the pools encountered, yet they comprised 50% of the total length of pools.
