KARUK ECOSYSTEM RESTORATION PROGRAM

Progress Report

Steinacher Creek

PROGRESS REPORT **31 January 2001**

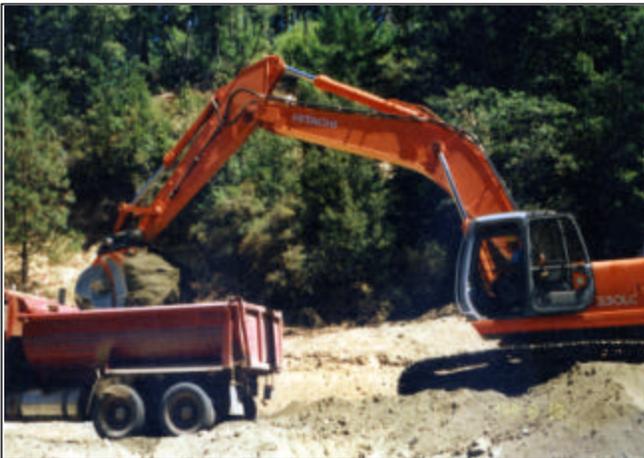
Excavator loading dump truck at RX10

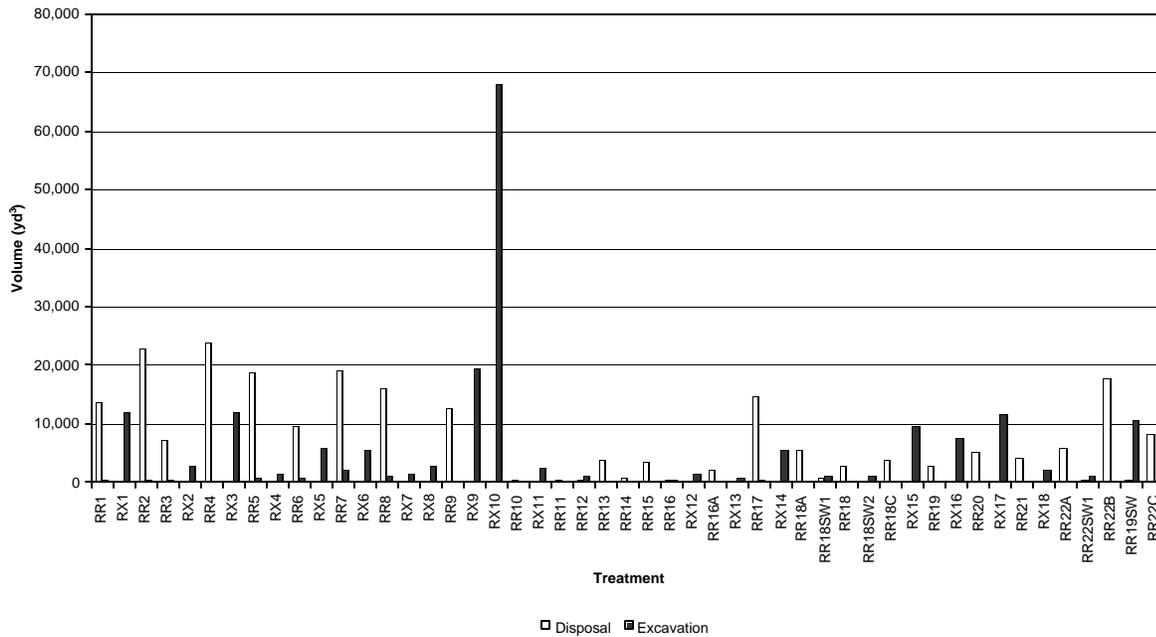
Figure 2. Revised treatment volume estimates.

Treatment Volume Estimates. All stream crossing excavations and a variety of road reach treatments required volume calculations for managing fill materials, developing the work schedule, and for estimating costs. A detailed volume survey was undertaken to revise prescriptions and improve the accuracy of earlier excavation and storage volume estimates. Figure 2 shows the results of the new volume survey.

Stream crossings and swale treatments account for 94 percent of the total 196,056 yd³ volume needing to be excavated on the project. (Excavation sites range in volume from about 1,100 yd³ to nearly 68,000 yd³ in size.) Road reach volume storage capacities range from about 200 yd³ to about 24,000 yd³ in size, and collectively have a maximum-engineered capacity of 228,919 yd³ to dispose fill material along the entire road (see Appendix 3). Note the sharp excavation volume spikes at RX9 and R 10 and the lack of disposal space adjacent to them (discussed below).

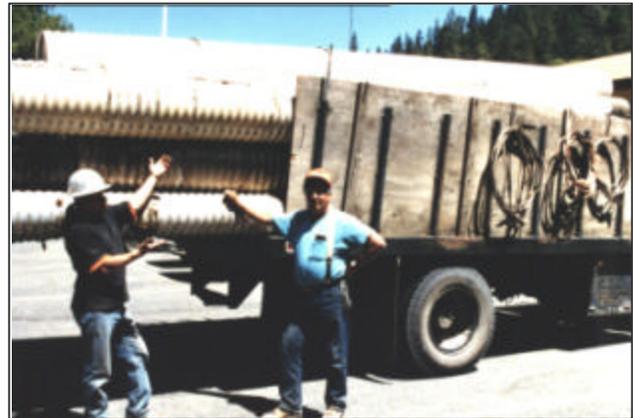
Culvert downspout being removed from the project.

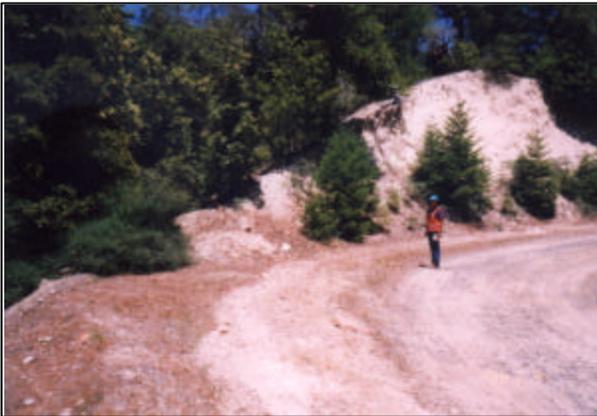
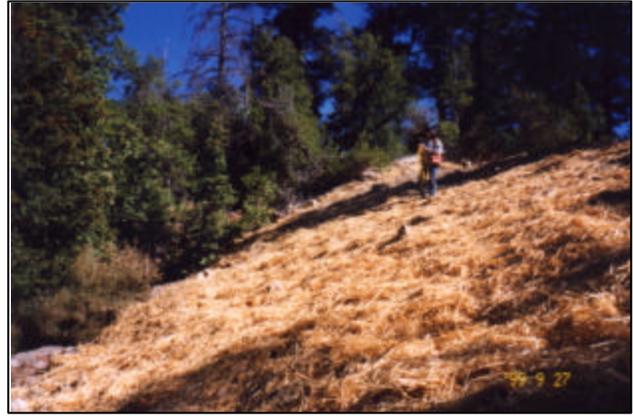
RR1 stored approximately 13,766 yd³ of fill: 600 yd³ was end-hauled from RX10; 11,164 yd³ was pushed by bulldozers from RX1; and 411 yd³ came from internal excavation sites. Before starting to excavate RX1, end-hauling to RR1 had to be completed. As well, before RX1 could be completed, all disposal outsloping within RR1 had to be finished.

Photo point showing before and after fill disposal in through-cut in RR1.

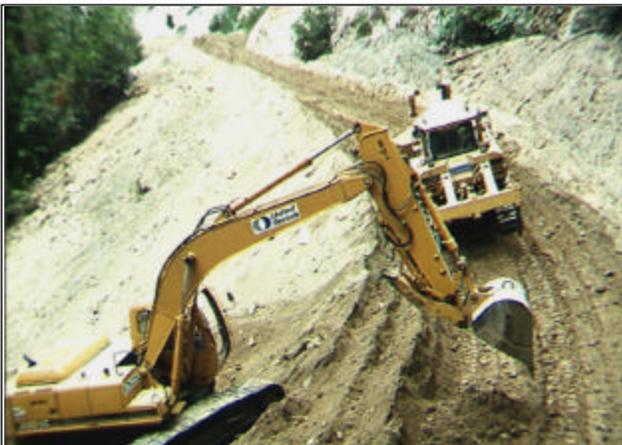
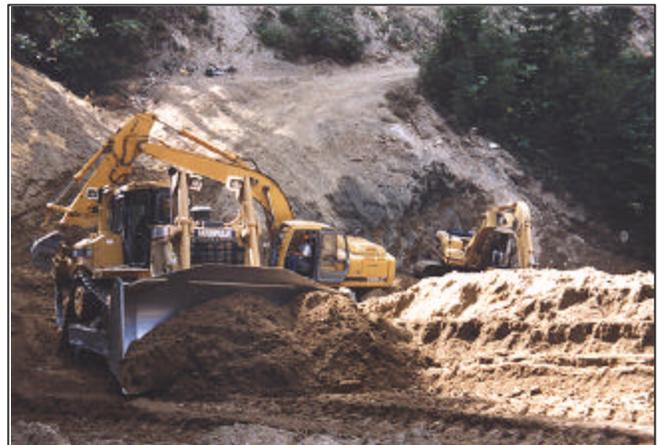
RX1 was a complicated double-crossing excavation with 12,151 yd³ of fill: channel A had a 48-inch culvert on grade with the natural bed; channel B had a 24-inch culvert that was not on grade. Both pipes contained flowing water at the time of excavation. Water quality measures were taken to safeguard off-site effects, which consisted of diverting flow away from the excavation and installing in-channel straw bale catchments. Approximately 92 percent of the fill material is disposed in RR1. The remaining 987 yd³ is disposed in RR2.

RX1 during excavation.

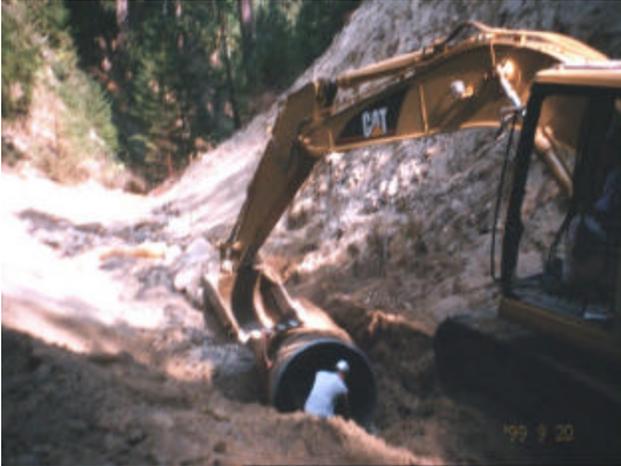
RX 1: culvert section being removed.

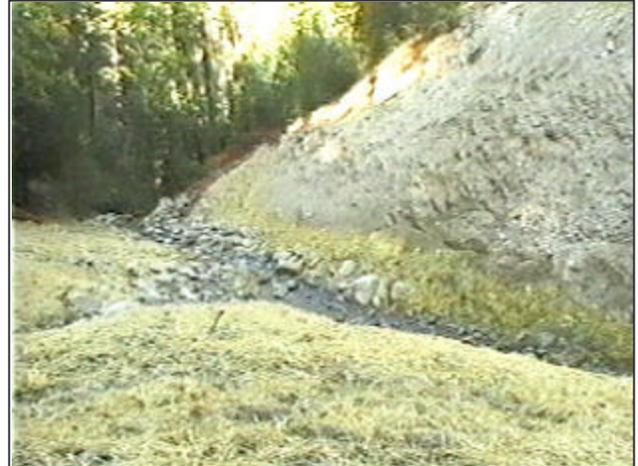
Completed RX1: note rocky outcrop on right bank and secondary channel entering from the left.

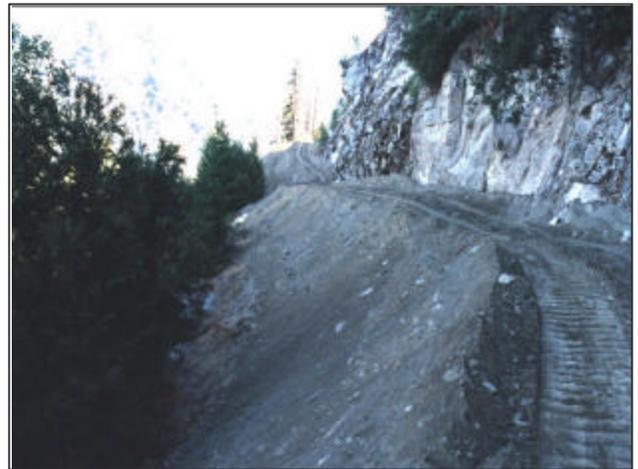
During imported fill disposal operations access to RX1 was maintained. Note the base of fill is at the outboard edge of the road.

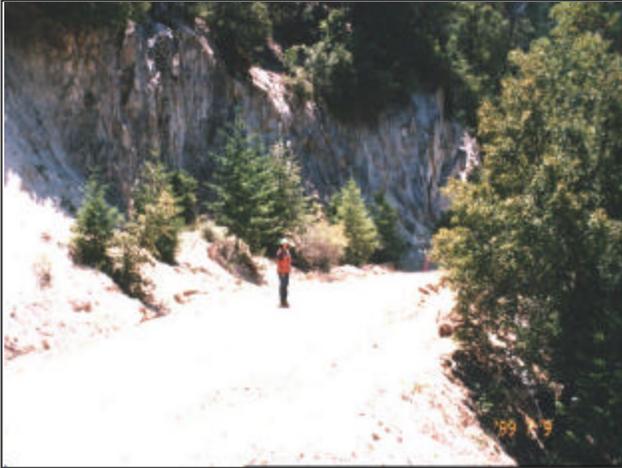
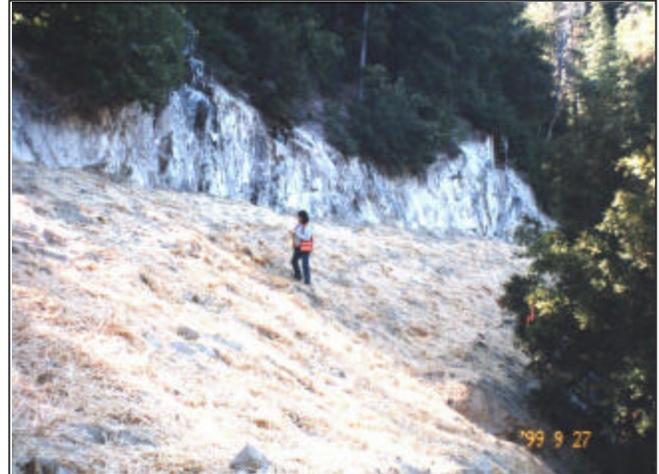
Photo point showing before and after importing fill and outsloping.

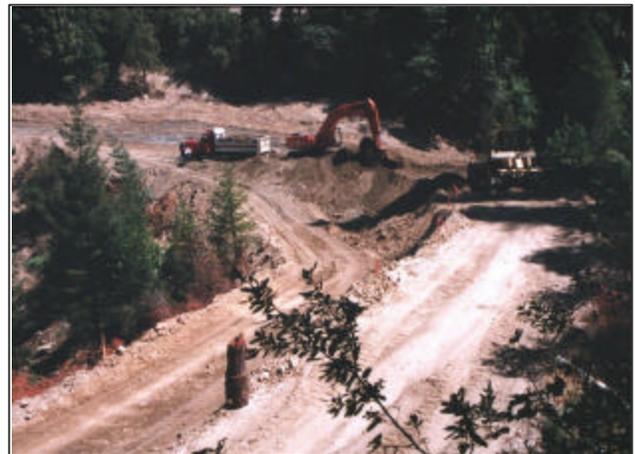
Size can be deceptive in photographs. RX10 (on the right) is less than half excavated, and about 36,028 yd³ remain.

Approximately 31,800 yd³ was end-hauled from RX10.

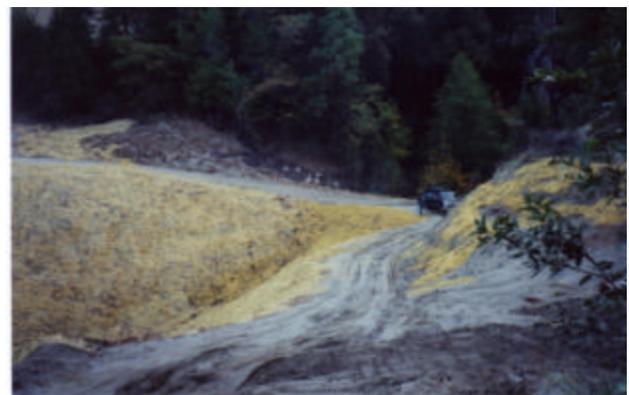
RX10: November 2000 after winterization

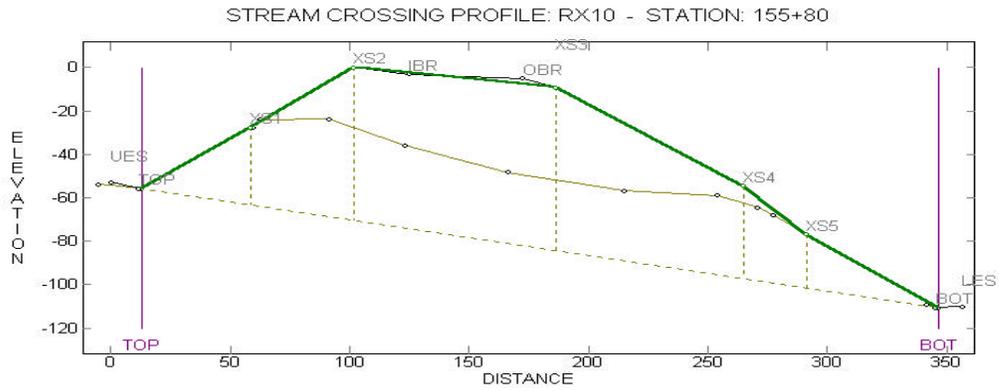
Figure 3 illustrates the current RX10 stream profile. The heavy line shows the original crossing profile and the lighter line shows the current profile. The dashed line at the bottom is the projected final channel grade. About 36,028 yd³ remains to be excavated.

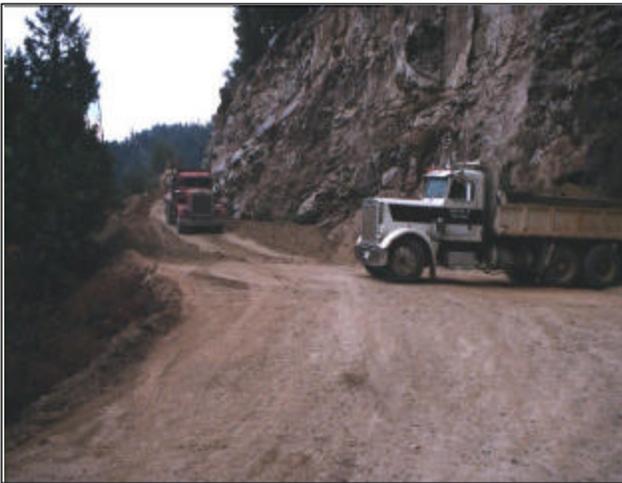
Trucks disposing of fill from RX10 into RR2 near photo point on right.

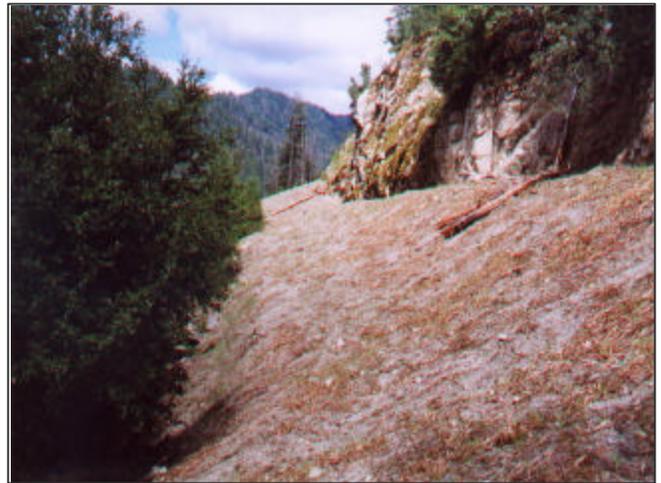
Photo point after outsliping imported fill.
